Structural Inspection Two Bridges and One Culvert

FOR
CONMEE TOWNSHIP

Structural Inspection Enders Road Bridge over Brule Creek

Structural Inspection Ilkka Drive Culvert at Brule Creek

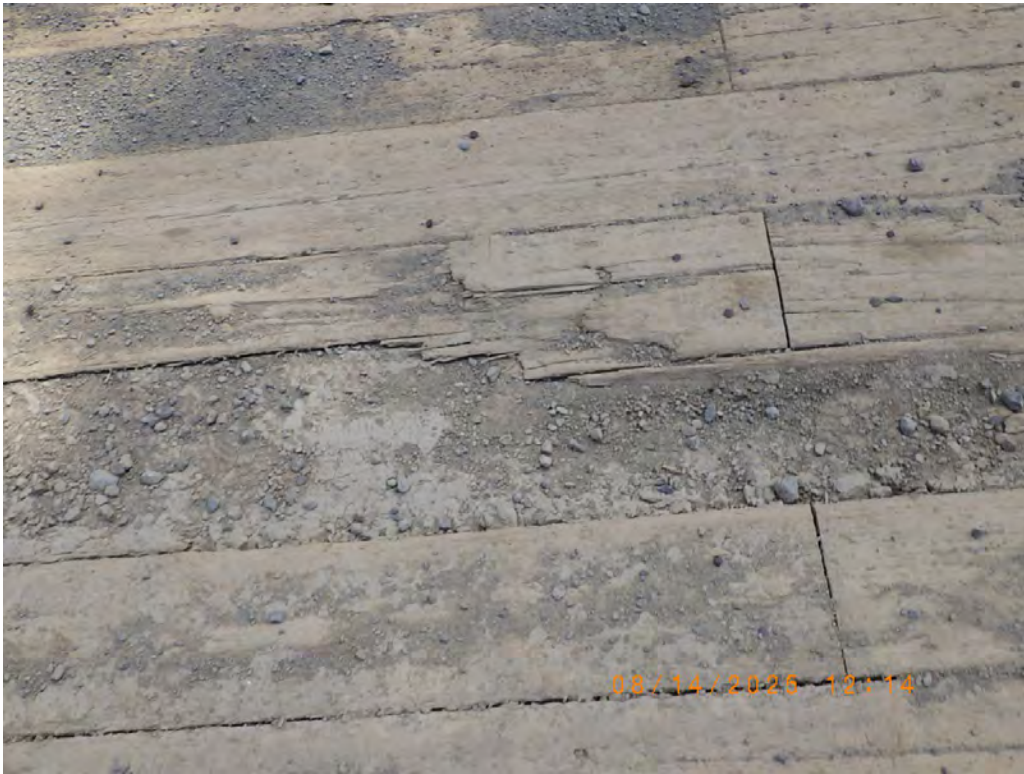
Severe rot was observed at eleven wearing surface planks. Gravel has accumulated at the sides of the wearing surface.

Photo 17: Severe rot at wearing surface planks.

- Replace eleven wearing surface planks. Remove gravel from the wearing surface.
- Extend the curb full length of the bridge at both sides.

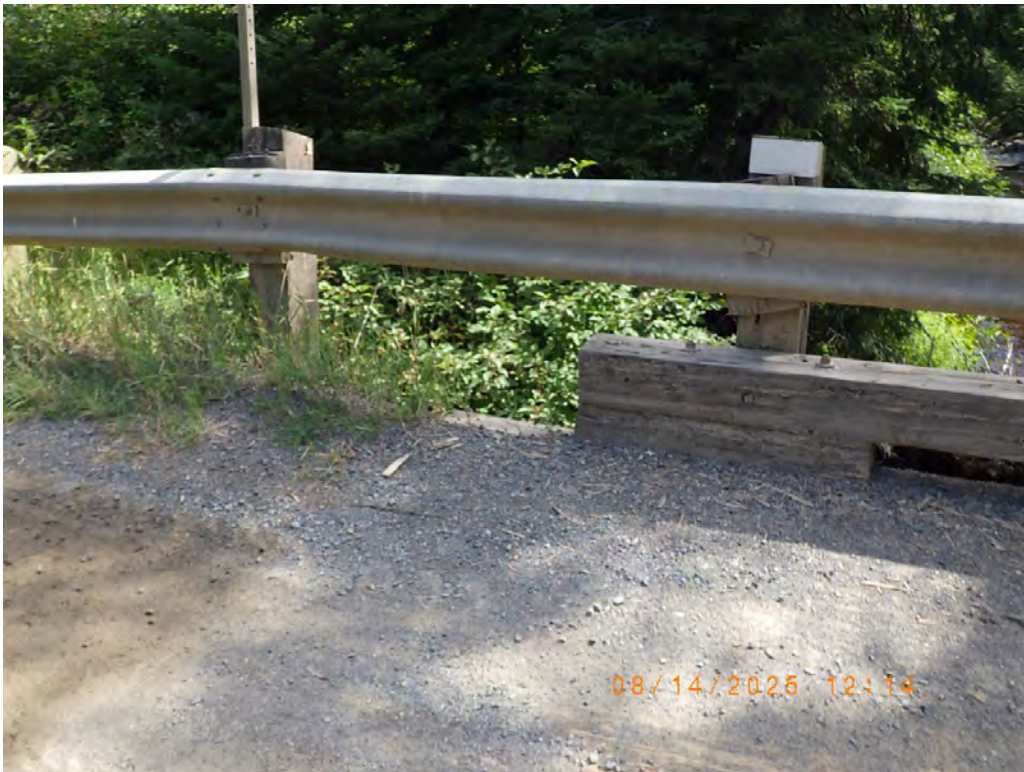
The steel flex beam guide rail is mounted approximately 200 mm too high along the deck and at the approaches. One bolt connecting the posts to the guide rail is loose.

Photo 18: Curb does not extend full length of bridge, guide rail mounted 200 mm too high.

Element Group:	Approach	Length:	6 m			
Element Name:	Railing System	Width:				
Location:	East and West Sides	Height:	0.79 m			
Material:	Steel	Count:	4			
Element Type:	Steel Flex Beam on Timber Posts	Total Quantity:	24 m			
Environment:	Benign / Moderate / <u>Severe</u>		Limited Inspection <input type="checkbox"/>			
Protection System:	Hot dip galvanizing					Perform. Deficiencies
Condition Data:	Units	Exc.	Good	Fair	Poor	
	m ² /m / each / % / all		8		16	08
Comments: Railing system is mounted approximately 200 mm too high.						
Recommended Work:		<input checked="" type="checkbox"/> Rehab <input type="checkbox"/> Replace		Maintenance Needs:		00
		<input checked="" type="checkbox"/> 1-5 years <input type="checkbox"/> 6-10 years		<input type="checkbox"/> Urgent <input type="checkbox"/> 1 year <input type="checkbox"/> 2 year		
Lower railing system to proper height.

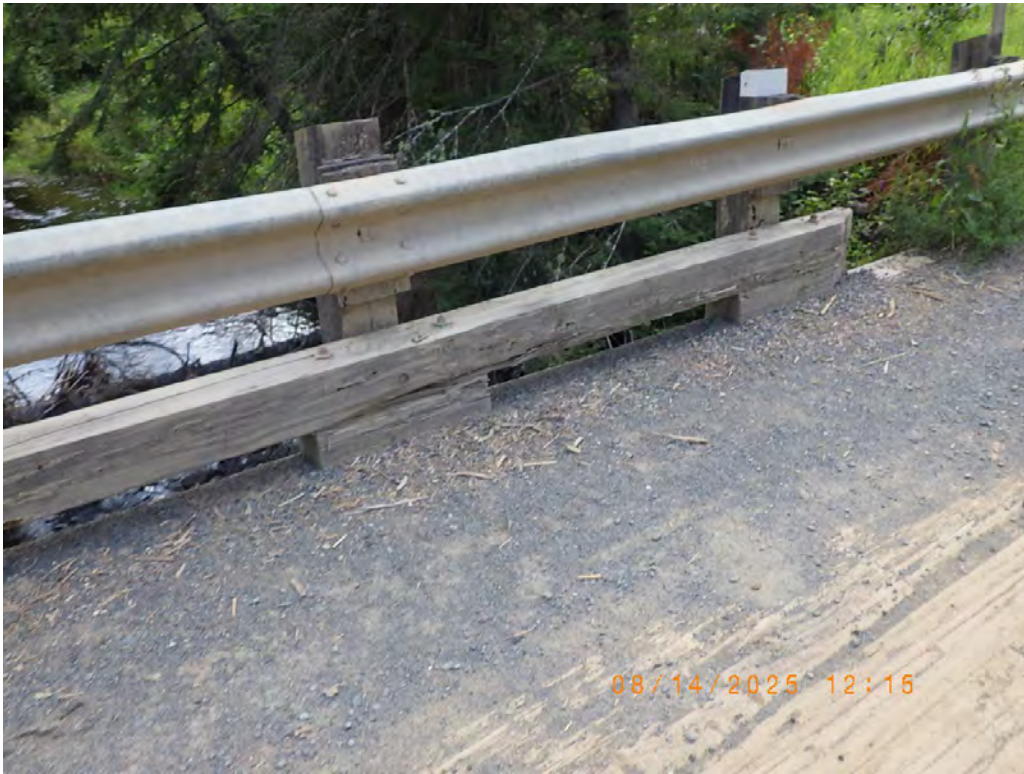
Photo 19: Medium abrasion at curb.

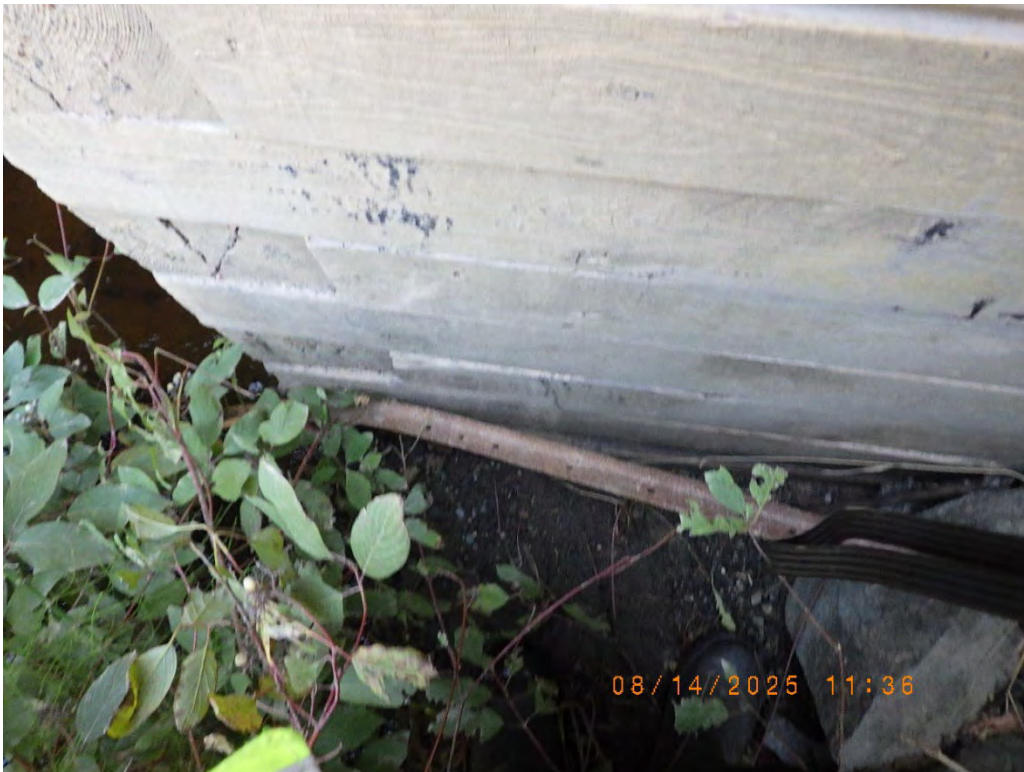
Photo 20: Loose steel angle next to southwest abutment.

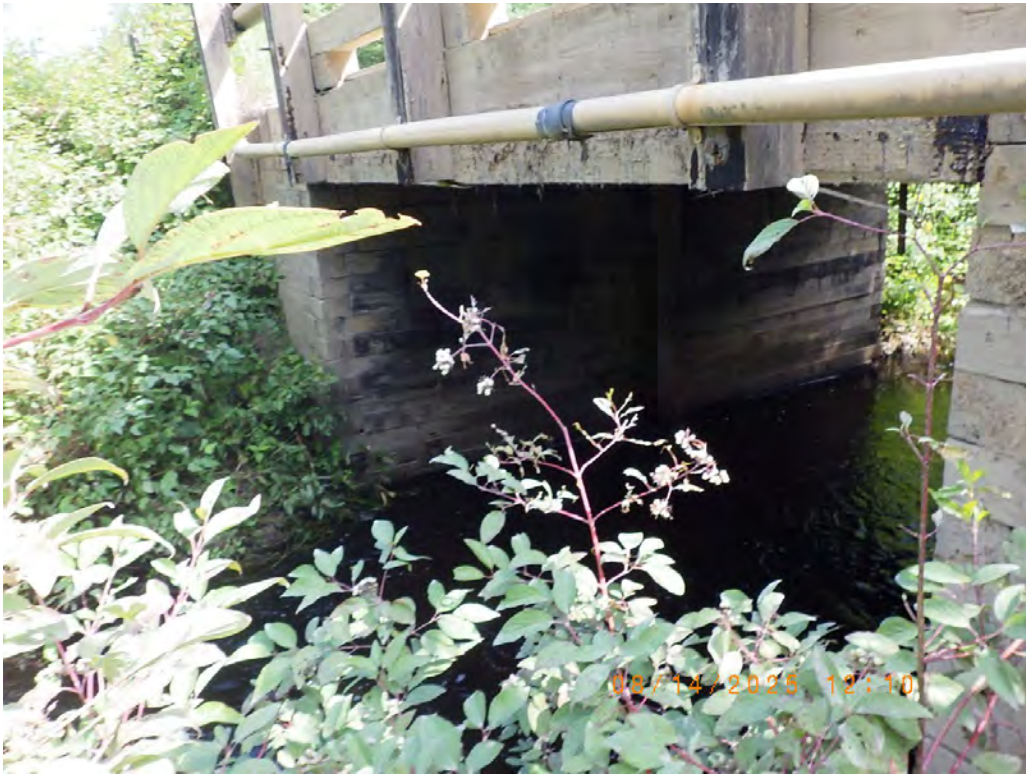
Photo 21: PVC pipe housing abandoned phone lines.

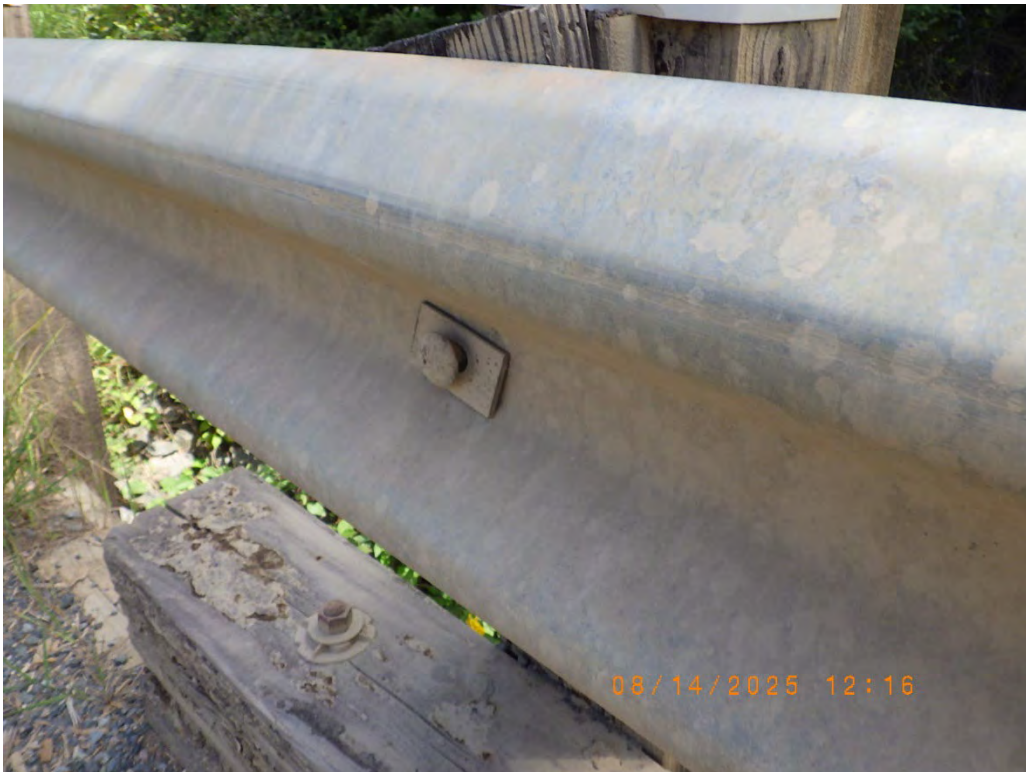
Photo 22: Loose guide rail splice bolt.

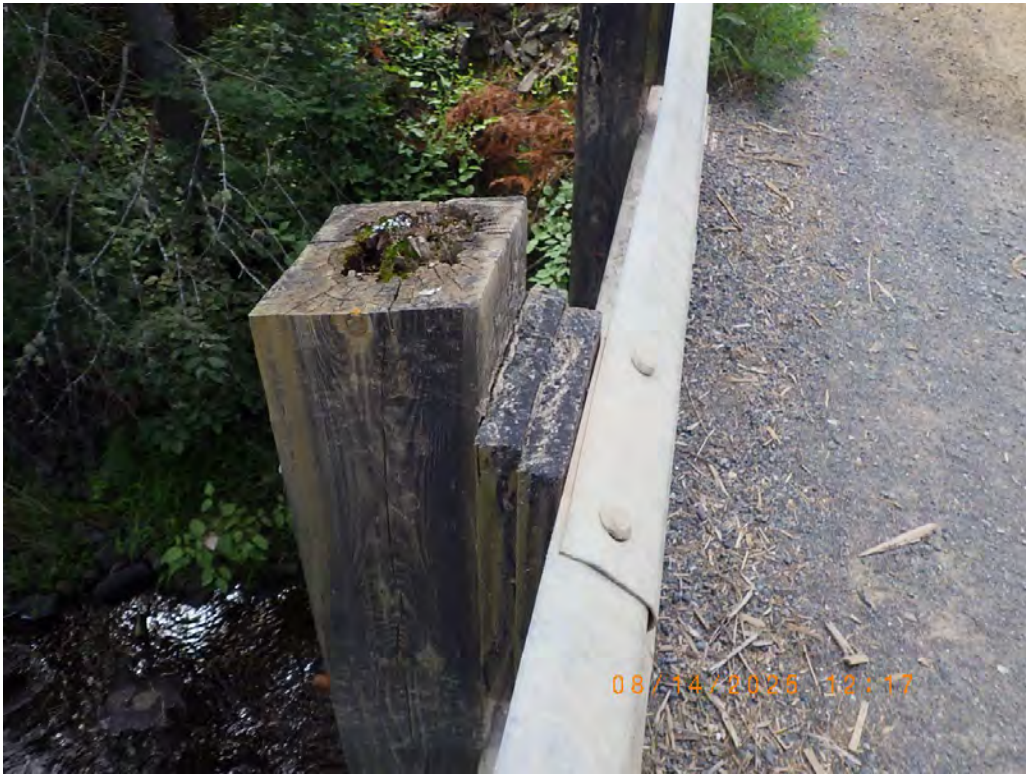
Five guide rail posts contain medium to severe end rot. The offset timbers at the bridge are not of a standard size and two offset blocks have rotated.

Photo 23: Medium to severe rot at posts.

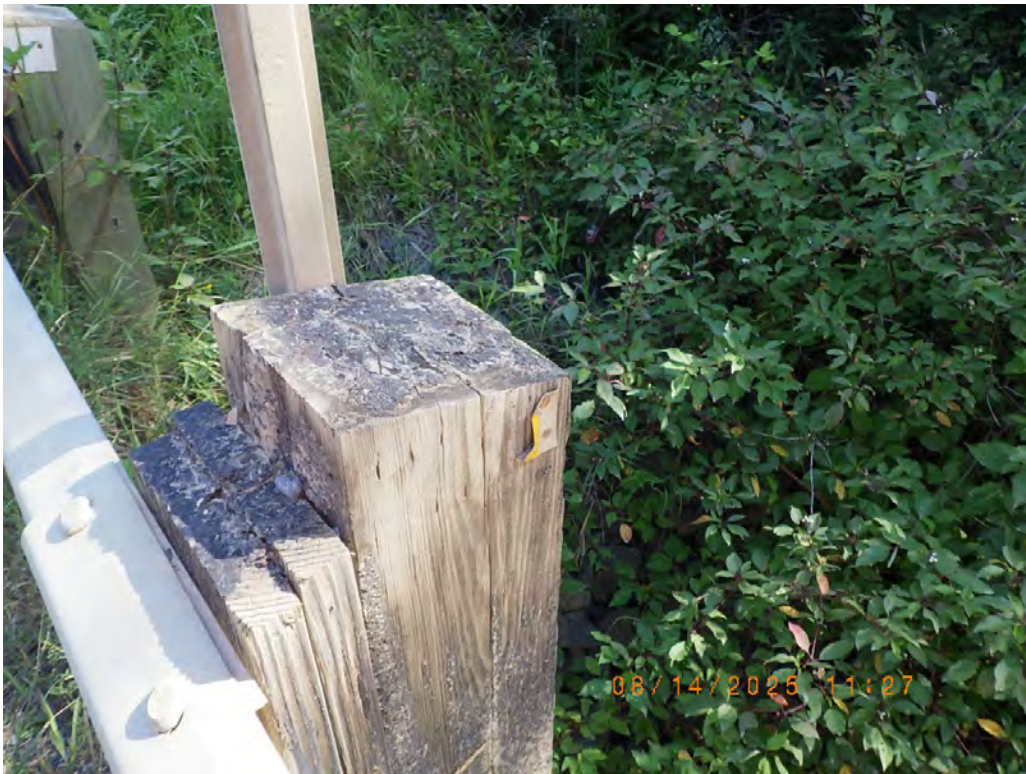
Photo 24: Broken reflector strip.

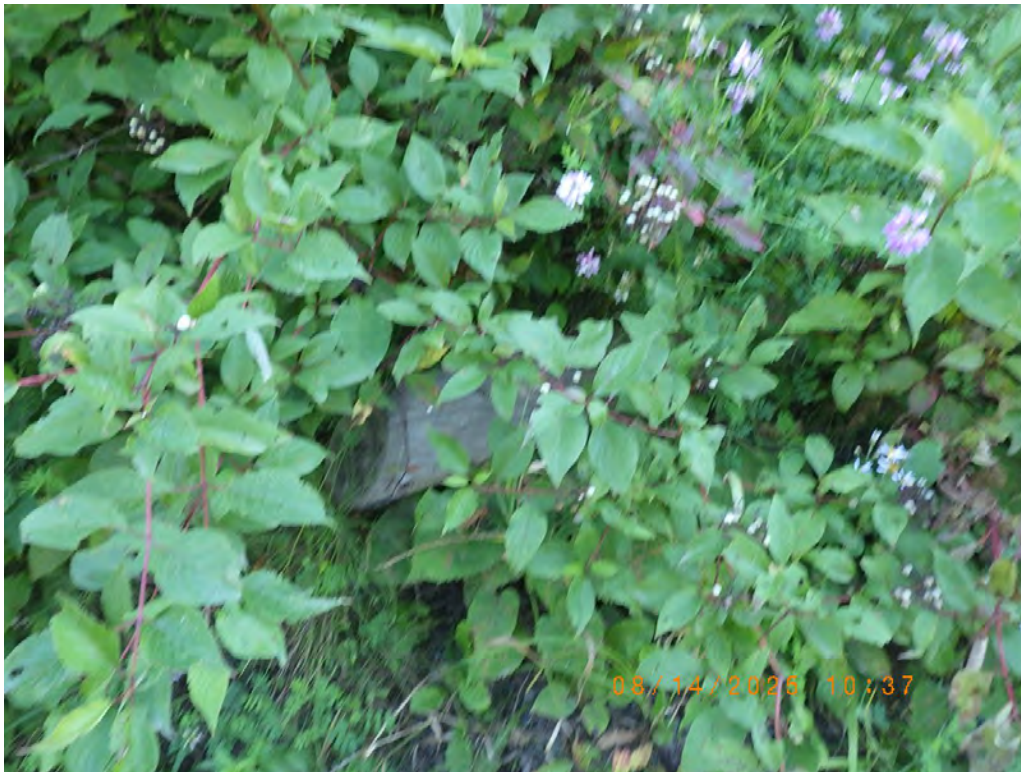
Photo 8: Broken guide rail posts.

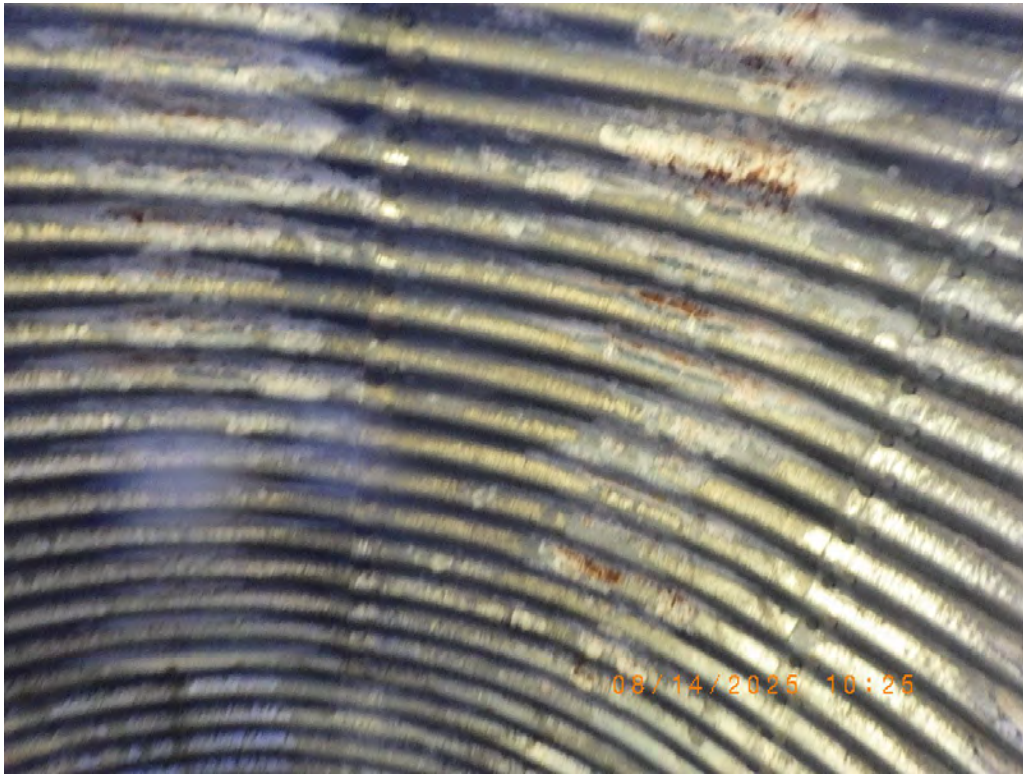
Photo 9: Light corrosion at top of barrel.

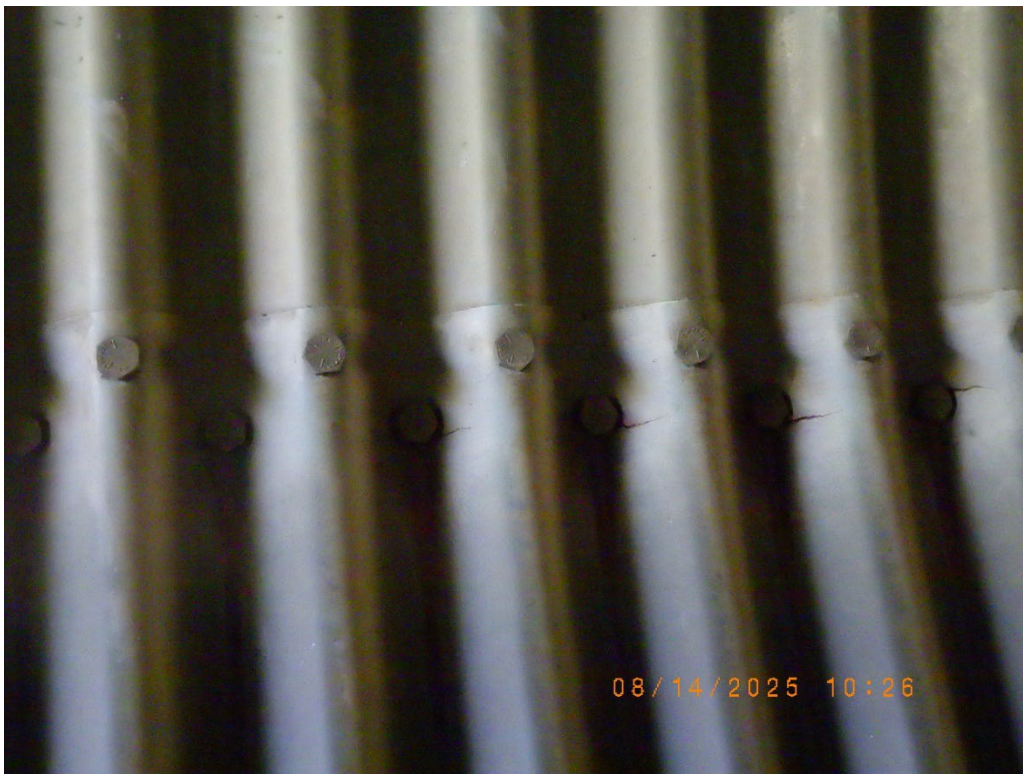
Cracking at the Ilkka Drive Culvert barrel indicates settlement or overstress has occurred. The estimated remaining life of this structure is 10-15 years based upon this deficiency. A Pre-Design Report should be done to determine the most feasible replacement or rehabilitation solution for this crossing.

Photo 10: Cracking at bolts inside barrel.

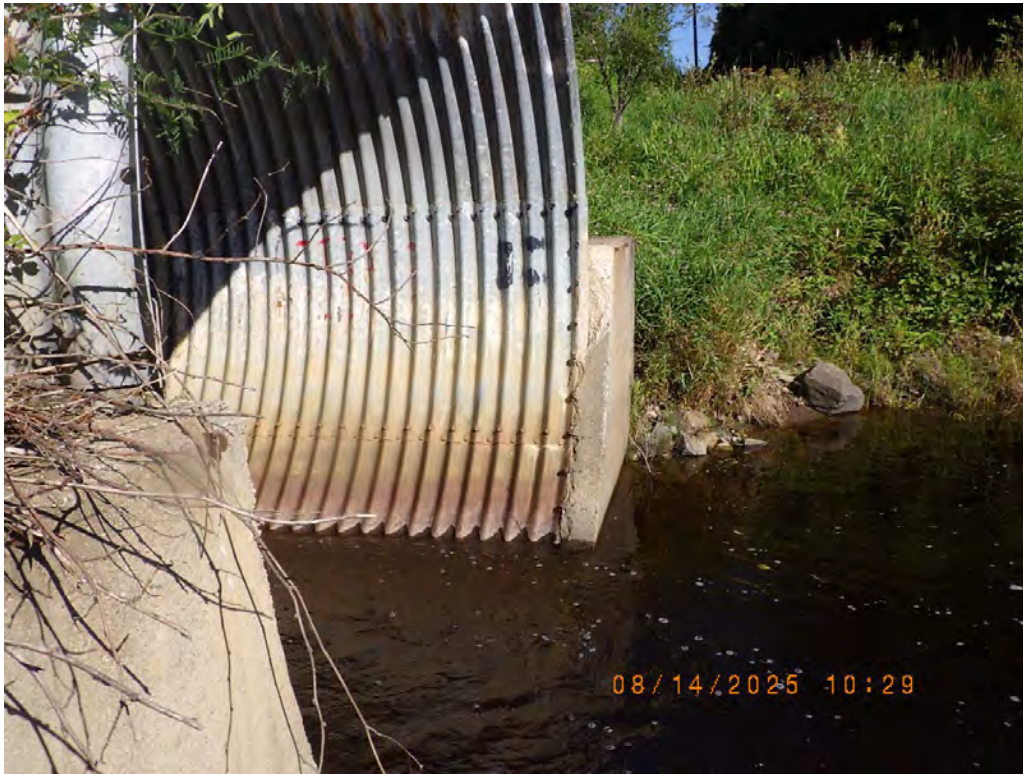
Photo 11: Scaling at downstream headwall.

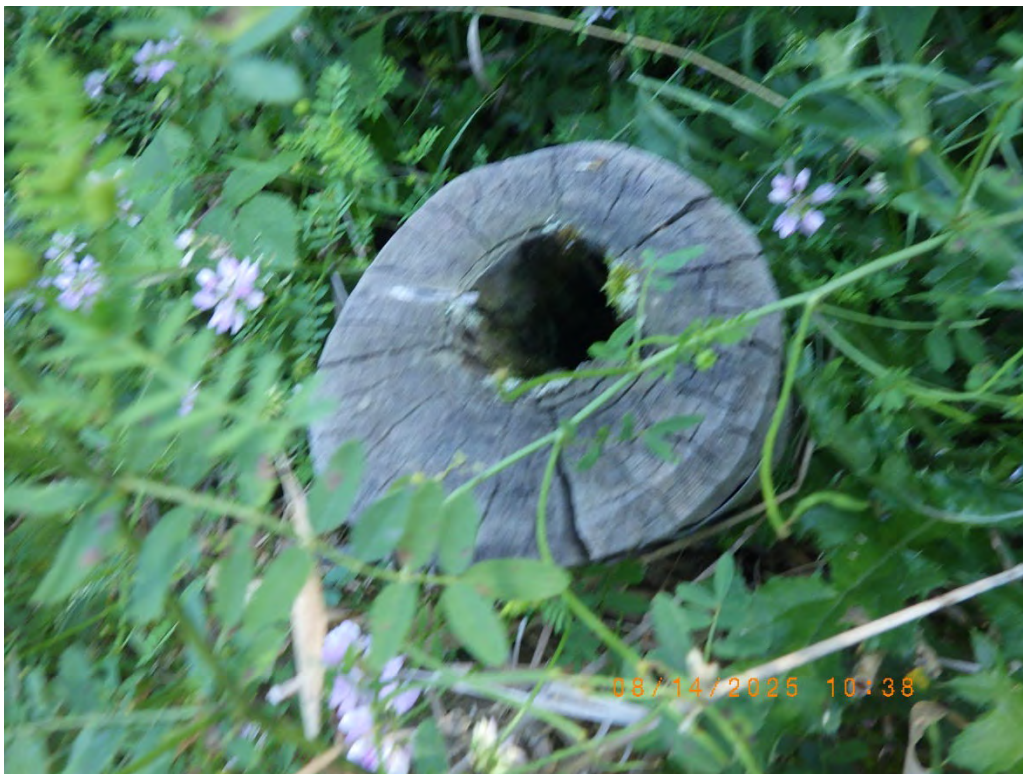
Photo 12: Severe section loss at guide rail posts.

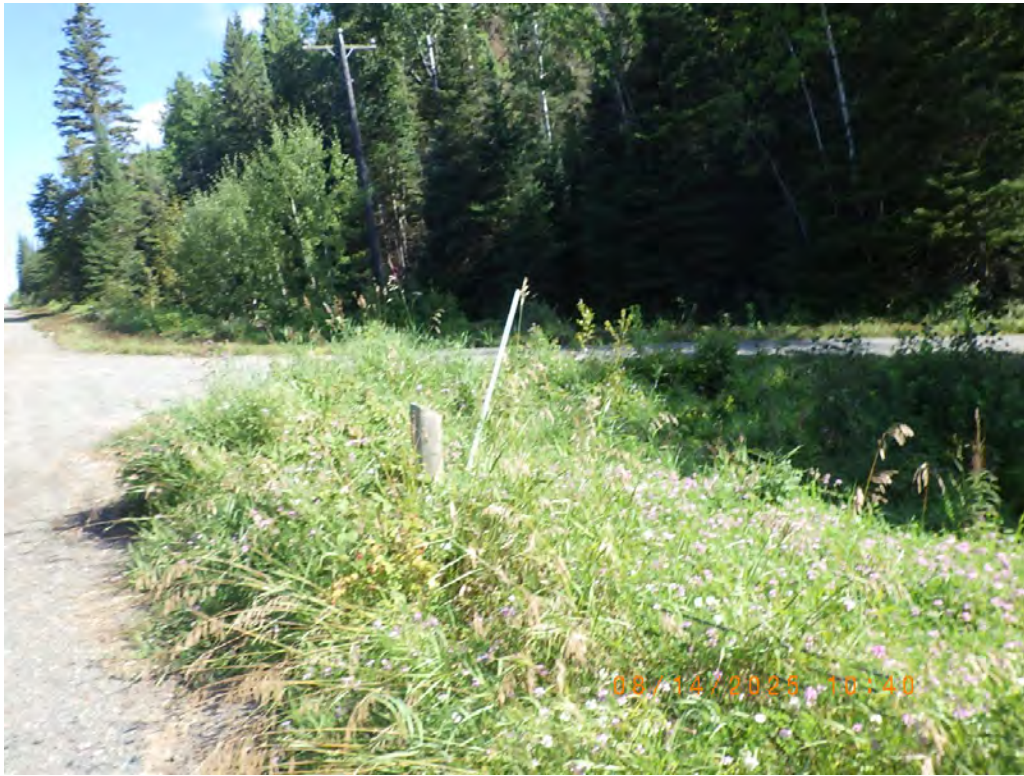
Photo 13: Sign post without sign.

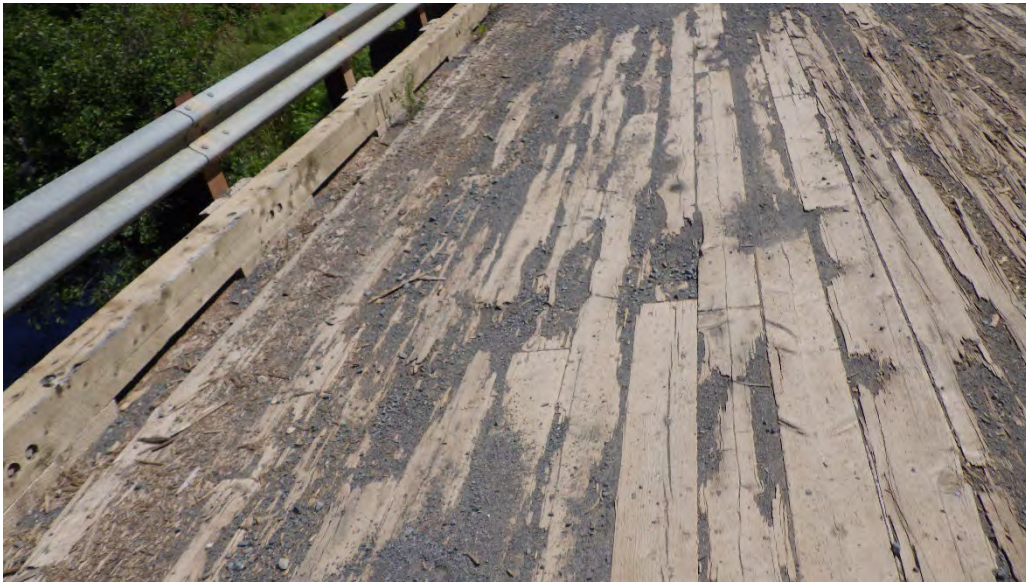
Photo 15: Severe rot at wearing surface planks.

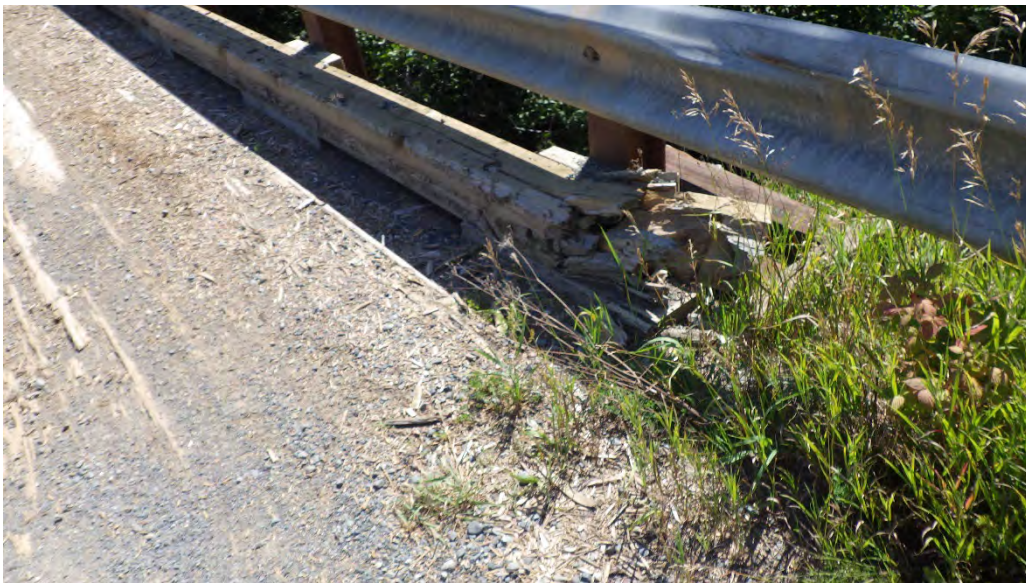
Photo 16: Impact damage at curb.

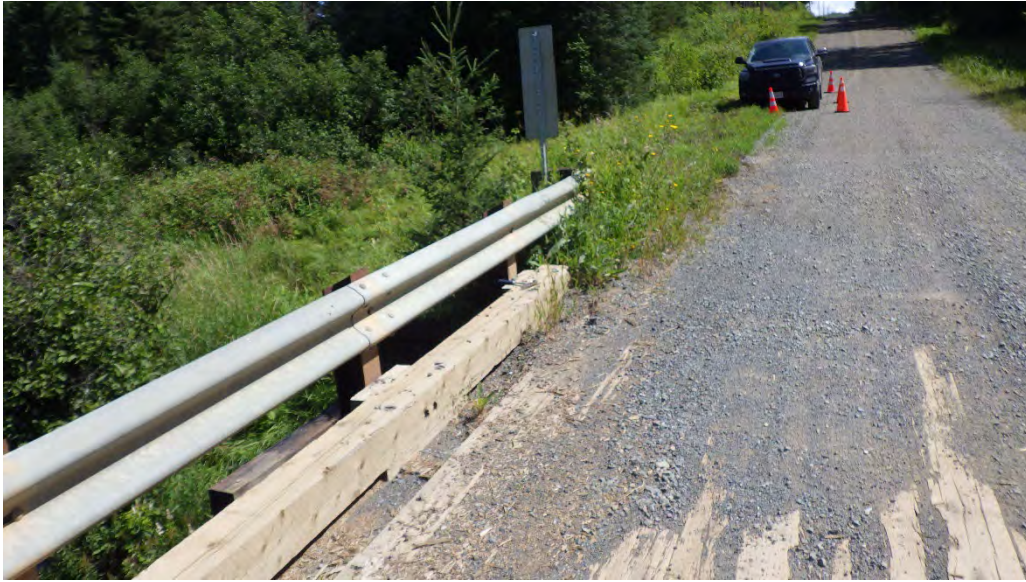
Photo 17: Gravel accumulation at corner of bridge.

Element Group:	Approaches	Length:	7 m			
Element Name:	Wearing Surfaces	Width:	5 m			
Location:	East and West Sides	Height:				
Material:	Asphalt	Count:	2			
Element Type:		Total Quantity:	70 sq. m.			
Environment:	Benign / Moderate <u>Severe</u>	Limited Inspection	<input type="checkbox"/>			
Protection System:						
Condition Data:	Units	Exc.	Good	Fair	Poor	Perform. Deficiencies
	<u>m²</u> /m / each / % / all			66	4	09
Comments: Gravel accumulation at both deck joints.						
Recommended Work:				Maintenance Needs:		
<input type="checkbox"/> Rehab <input type="checkbox"/> Replace <input type="checkbox"/> 1-5 years <input type="checkbox"/> 6-10 years				<input type="checkbox"/> Urgent <input checked="" type="checkbox"/> 1 year <input type="checkbox"/> 2 year		
				Remove gravel accumulation.

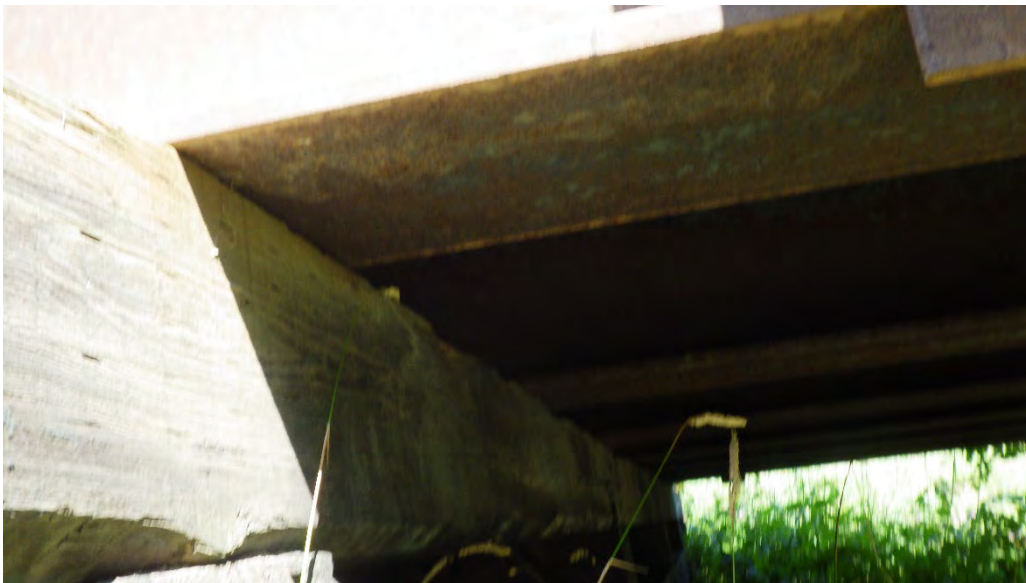
Photo 18: Girders bearing on front of abutment at west end.

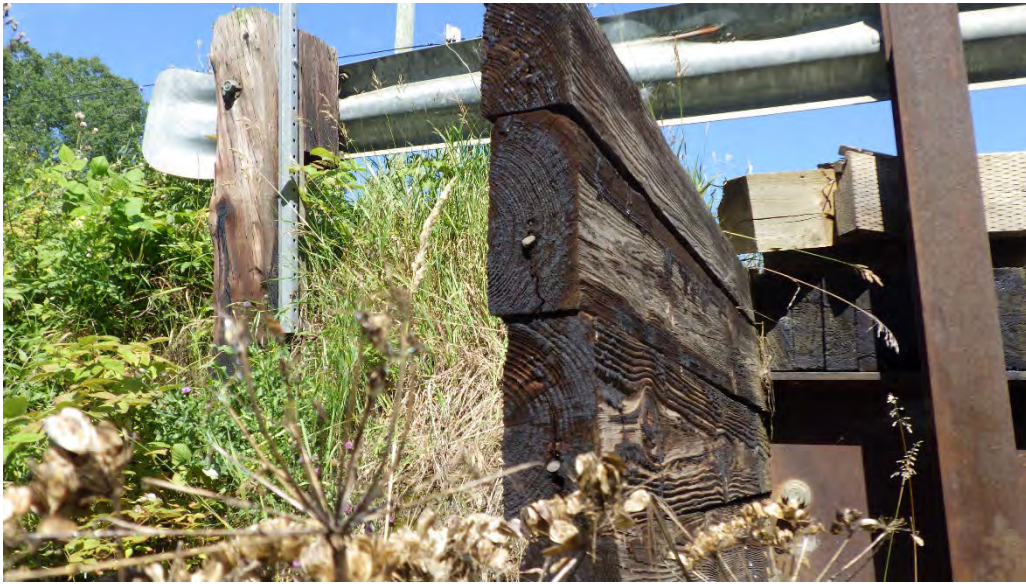
Photo 19: Crushing of ballast wall (typ.).

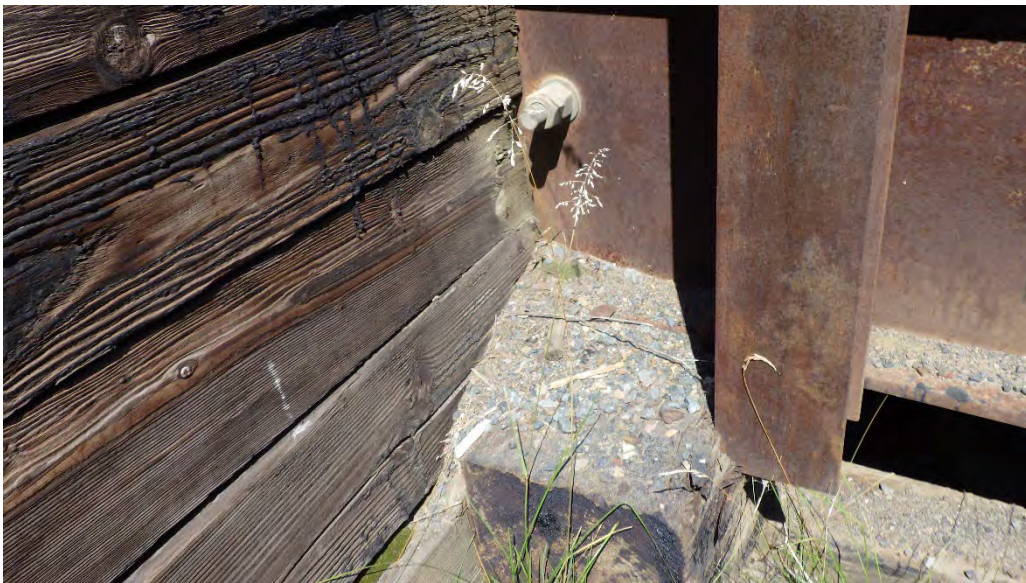
Photo 20: Gravel accumulation at bearing timber ends (typ.).

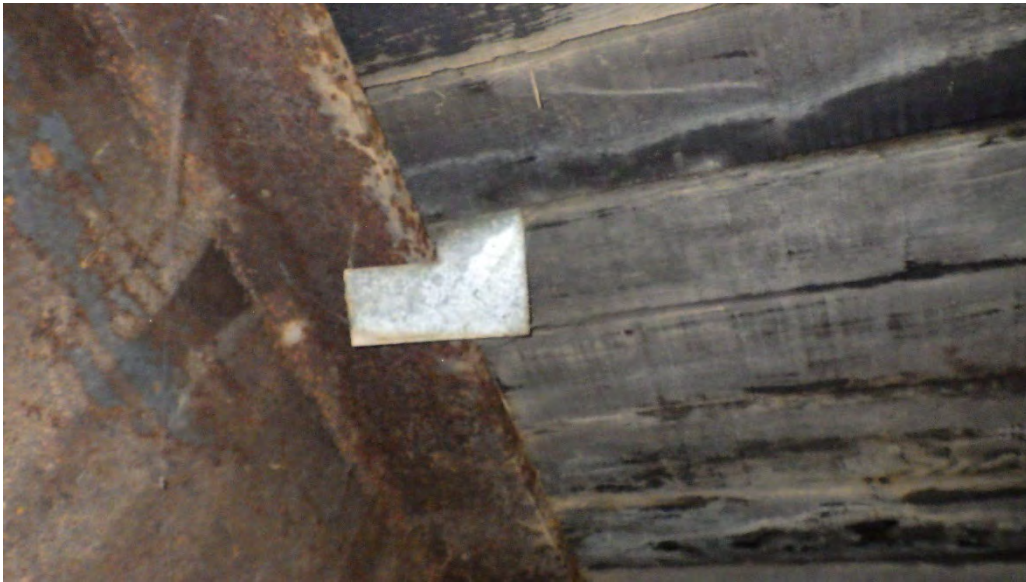
Photo 21: Damage deck clip (typ.).

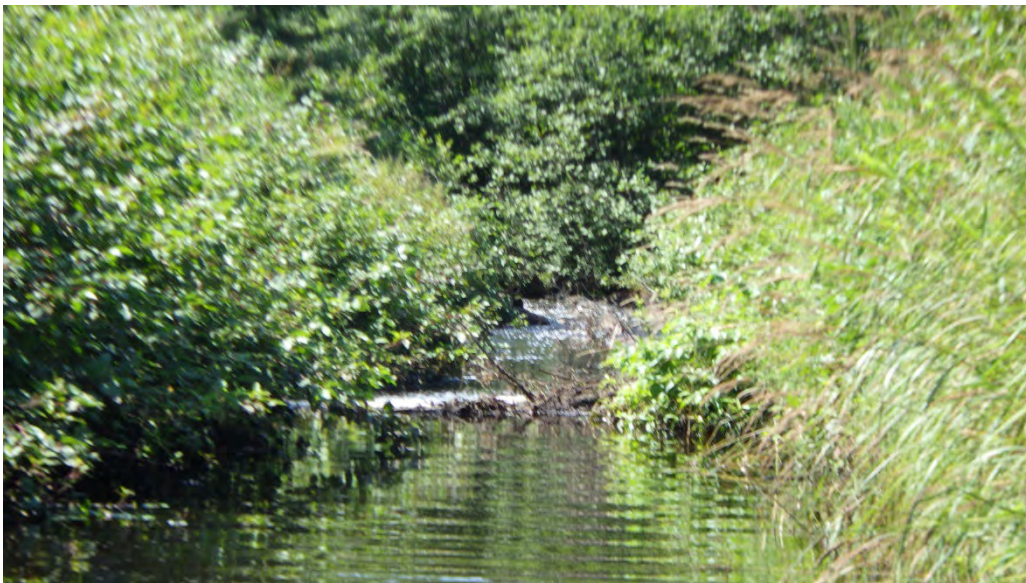
Photo 22: Beaver dam upstream of bridge.

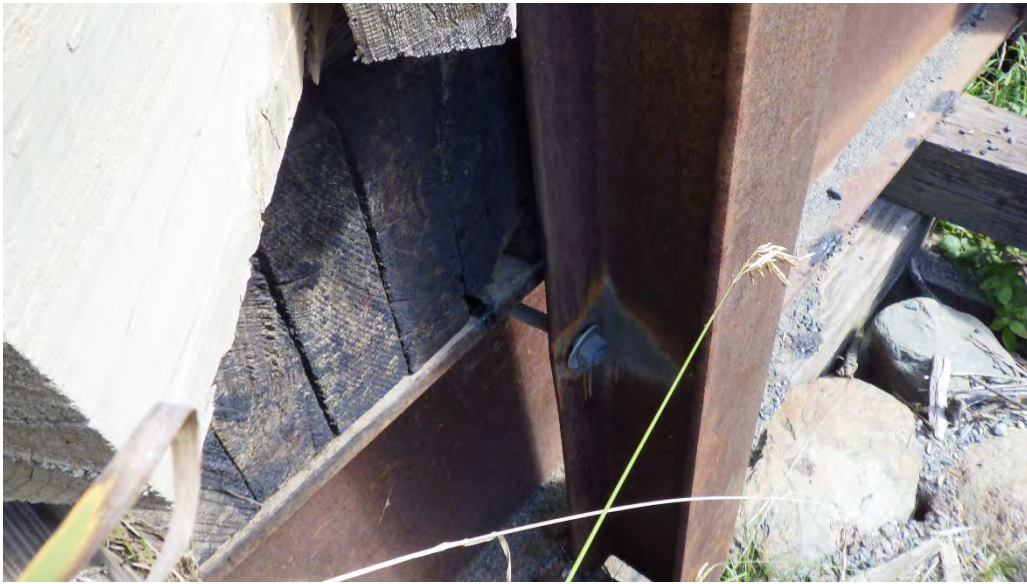
Photo 23: Loose bottom bolt on southwest steel post.
