Structural Inspection Two Bridges and One Culvert

FOR
CONMEE TOWNSHIP

Structural Inspection Enders Road Bridge over Brule Creek

Structural Inspection Ilkka Drive Culvert at Brule Creek

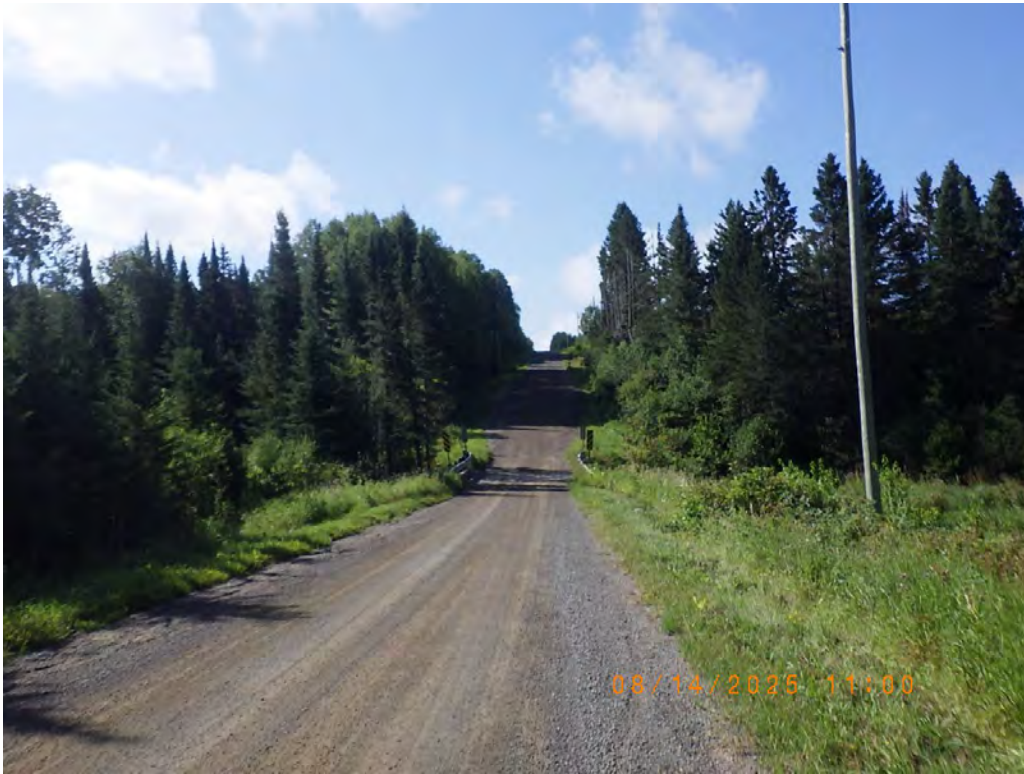
Photo 1: North approach.

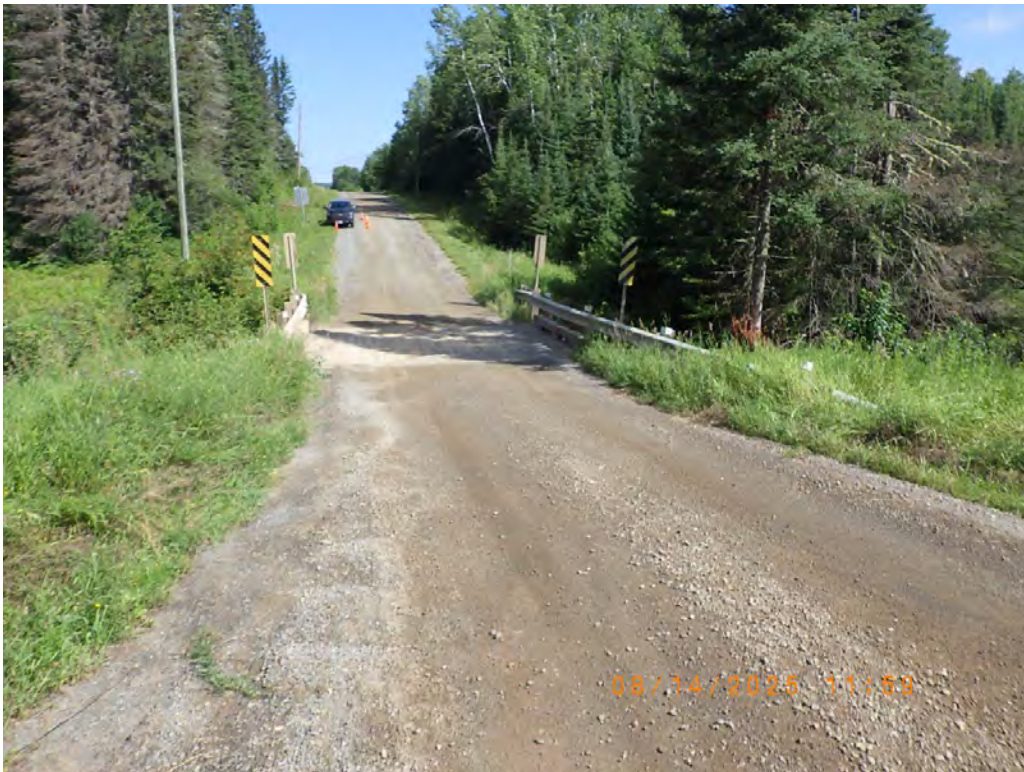
Photo 2: South approach.

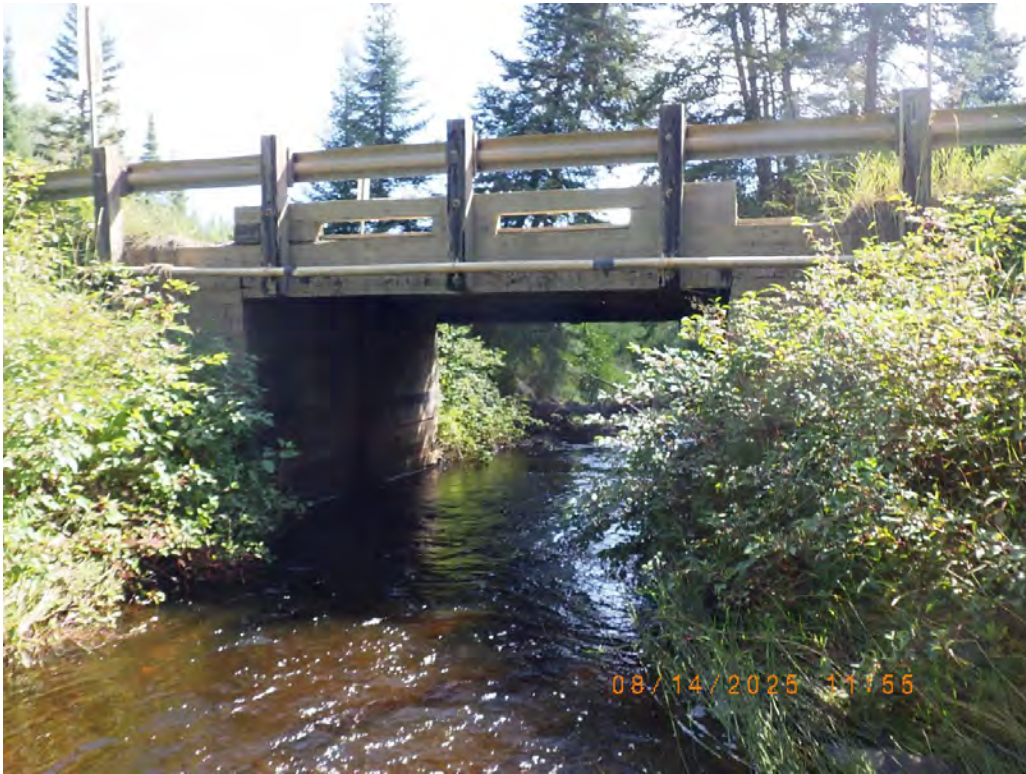
Photo 3: Upstream elevation looking west.

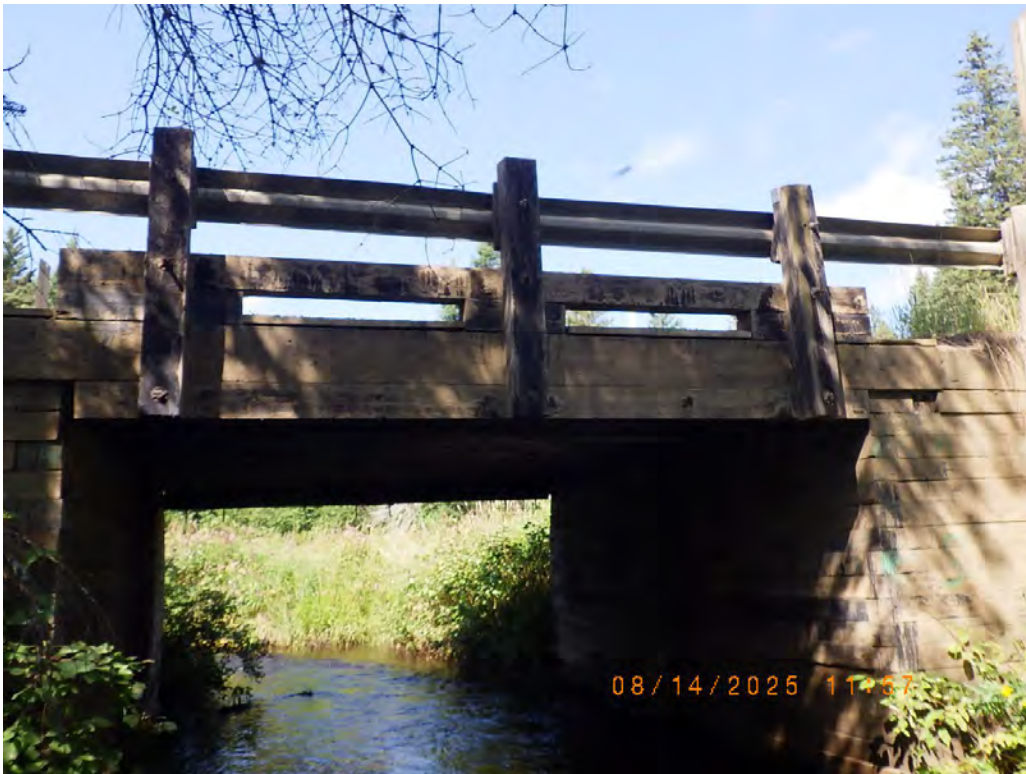
Photo 4: Downstream elevation looking east.

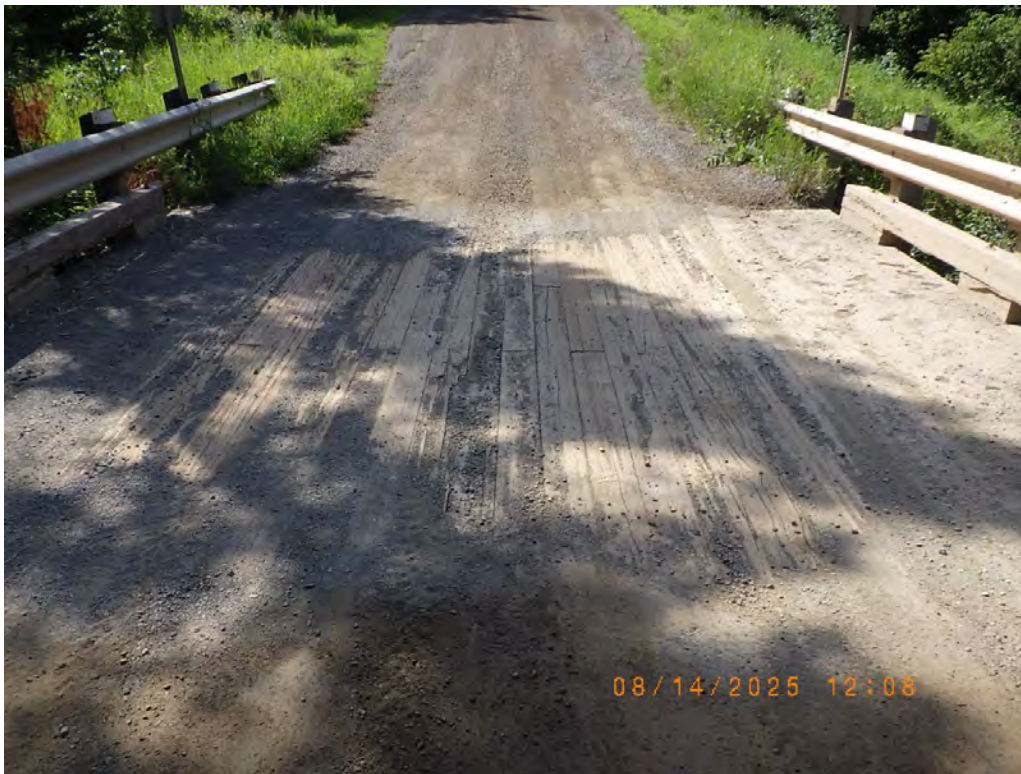
Photo 5: Deck cross-section.

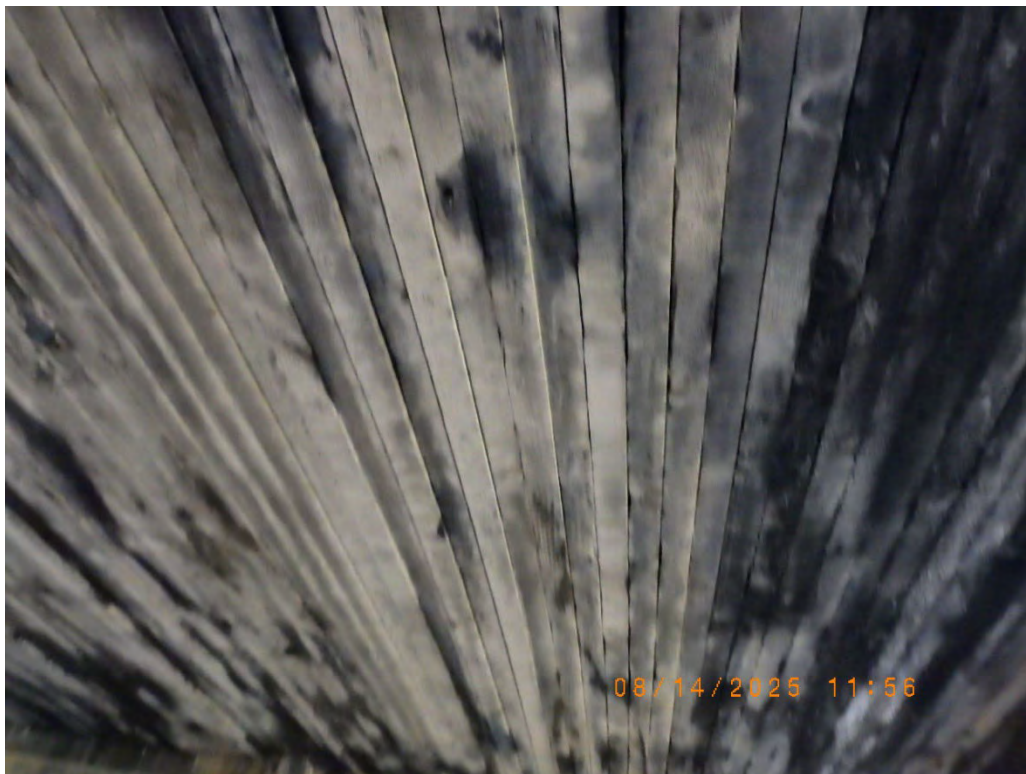
Photo 6: Underside of bridge.

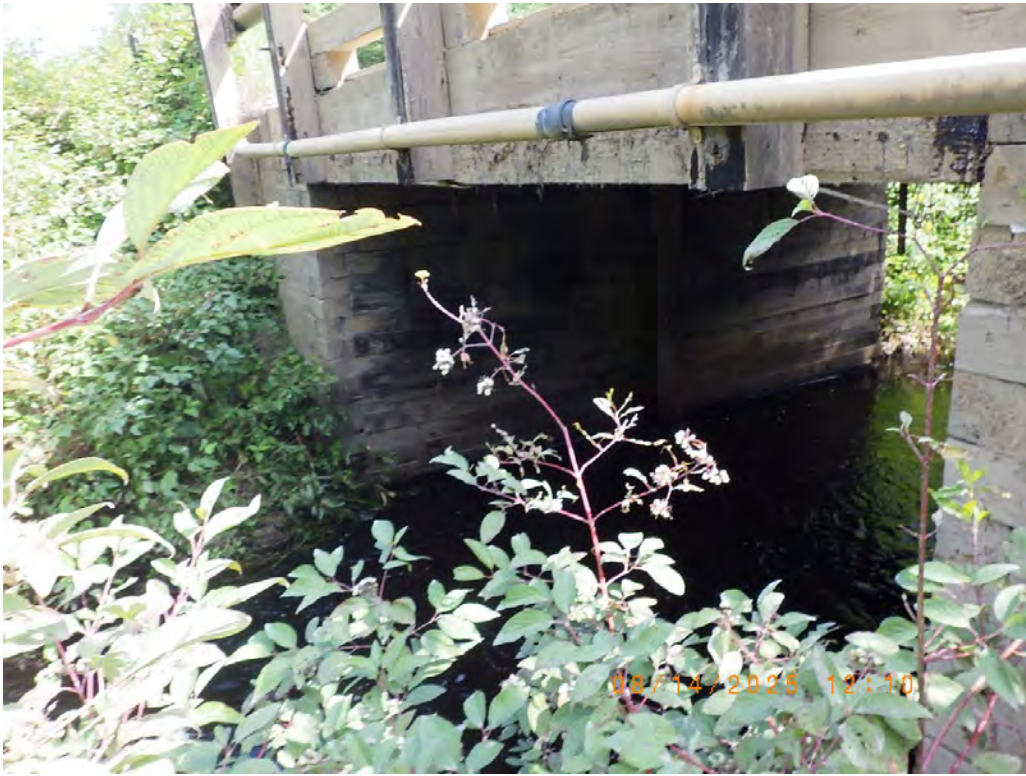
Photo 7: North abutment and embankment.

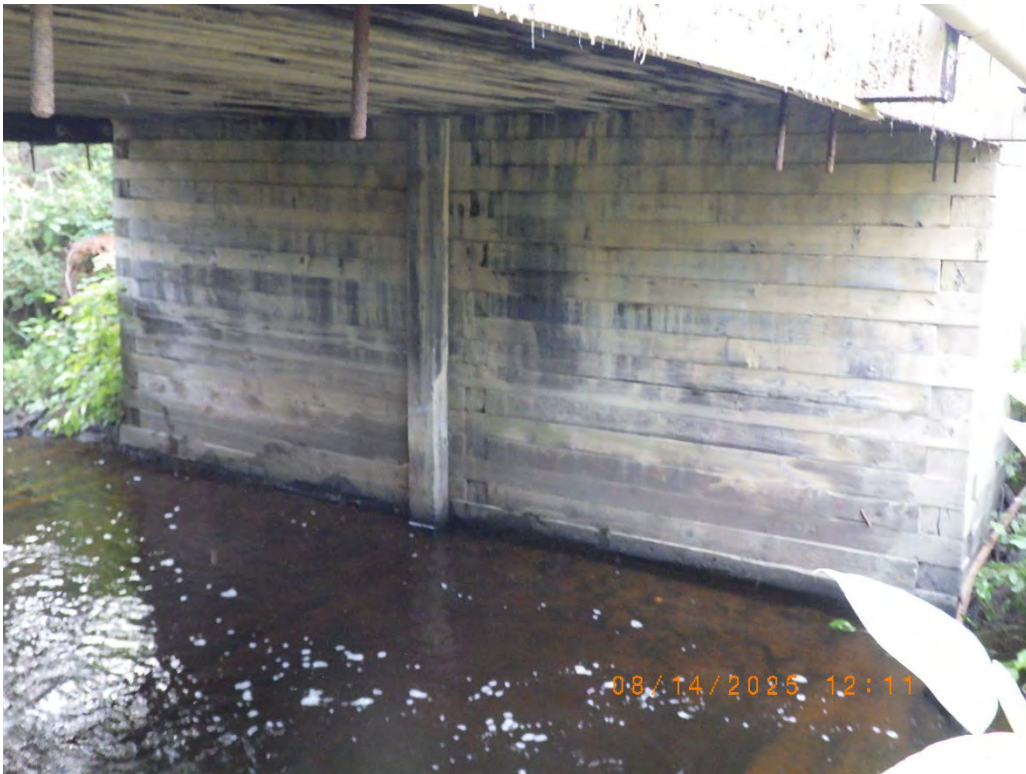
Photo 8: South abutment and embankment.

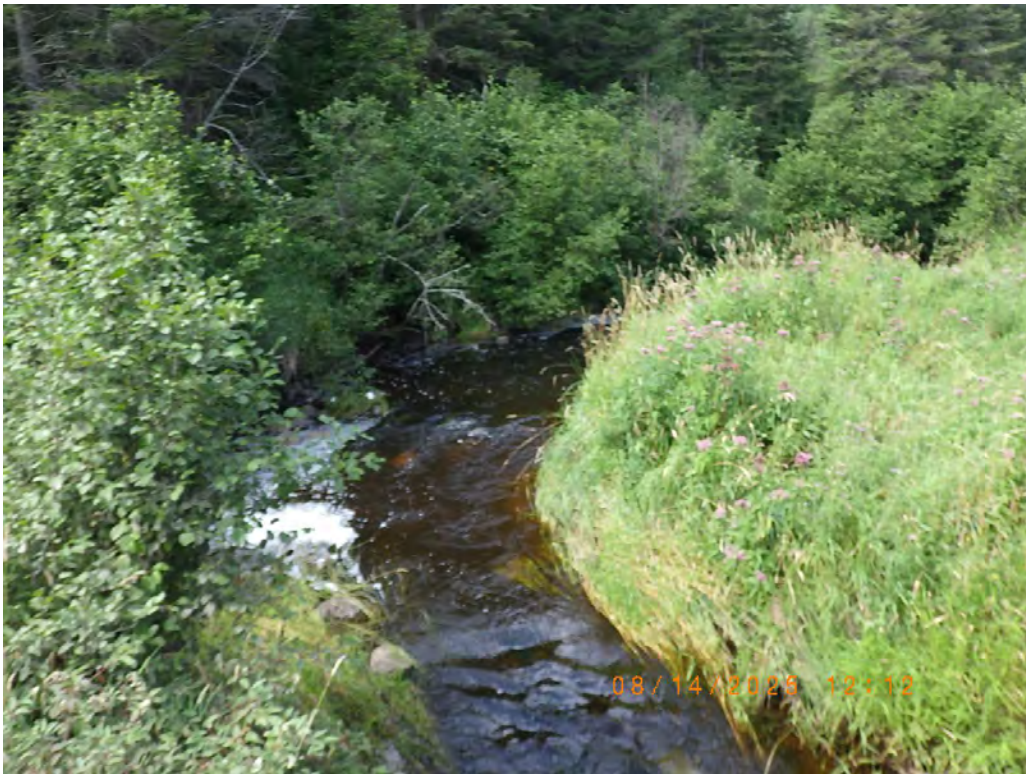
Photo 10: Upstream view from bridge.

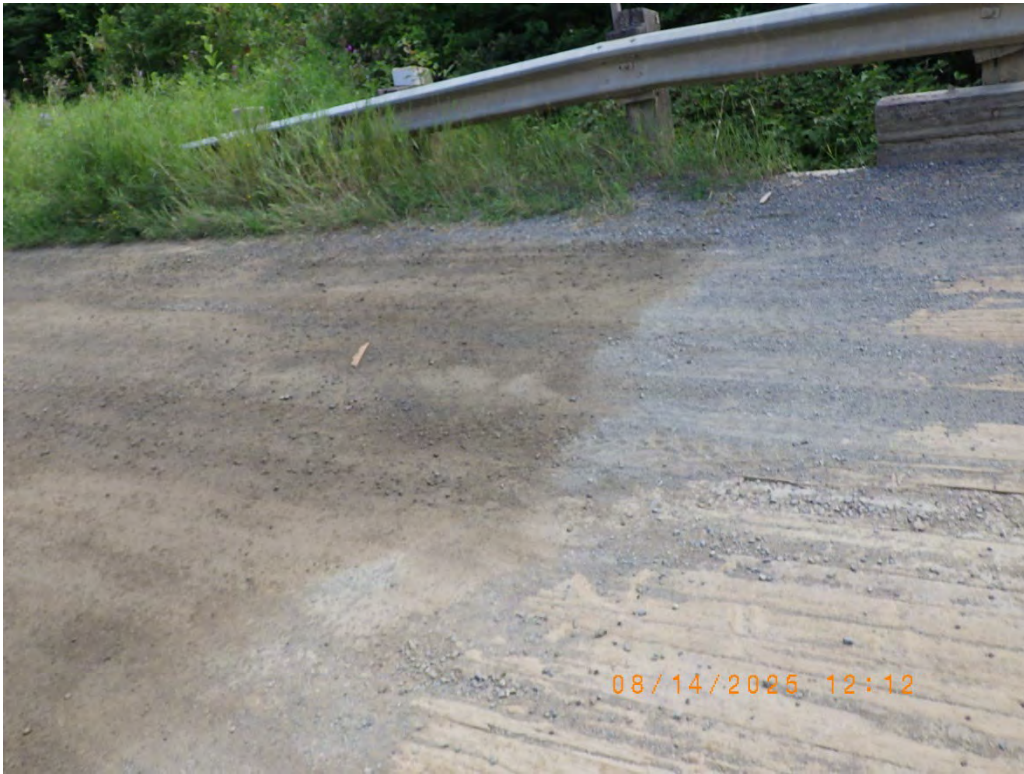
Photo 11: North deck joint.

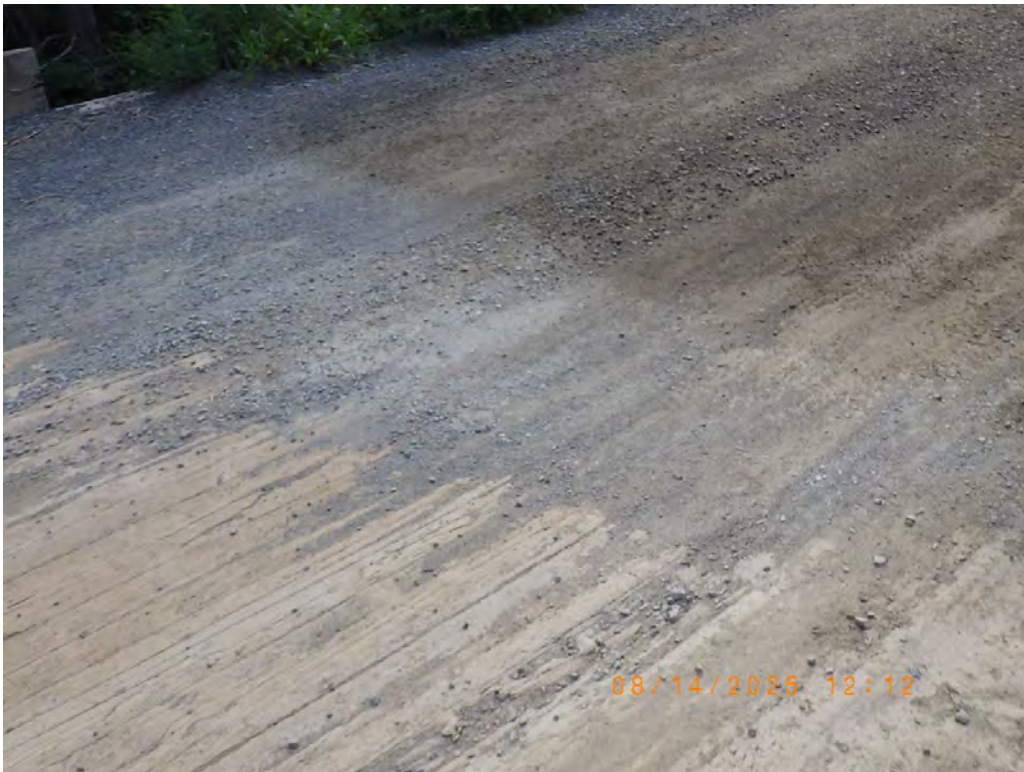
Photo 12: South deck joint.

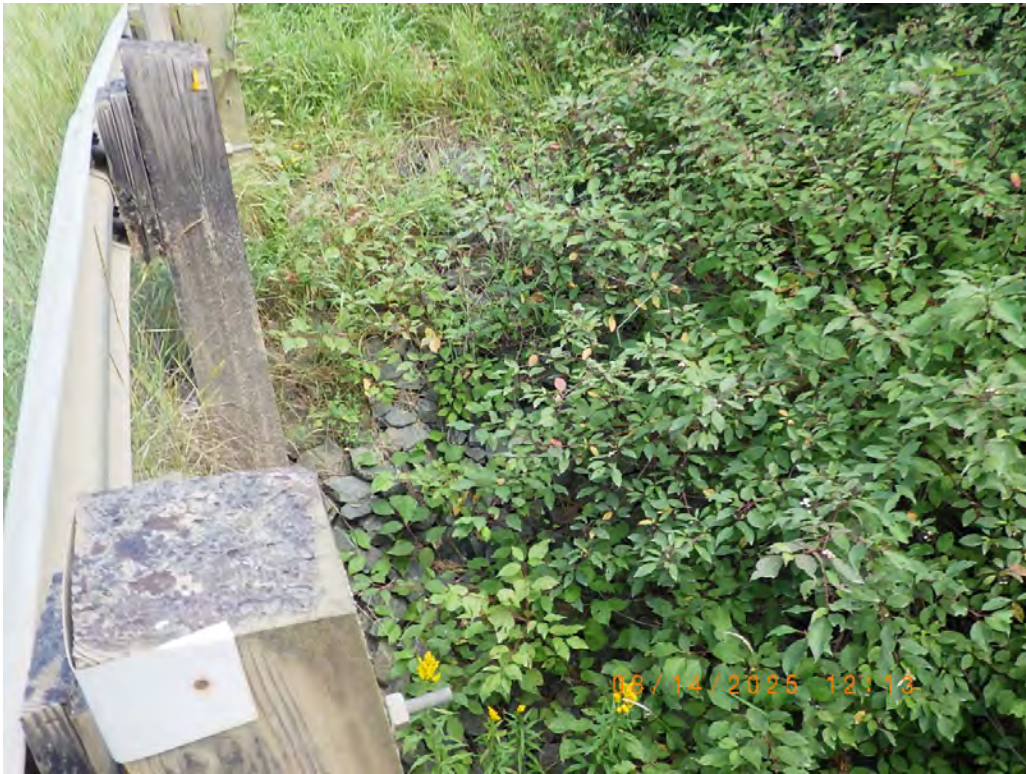
Photo 13: Northeast embankment.

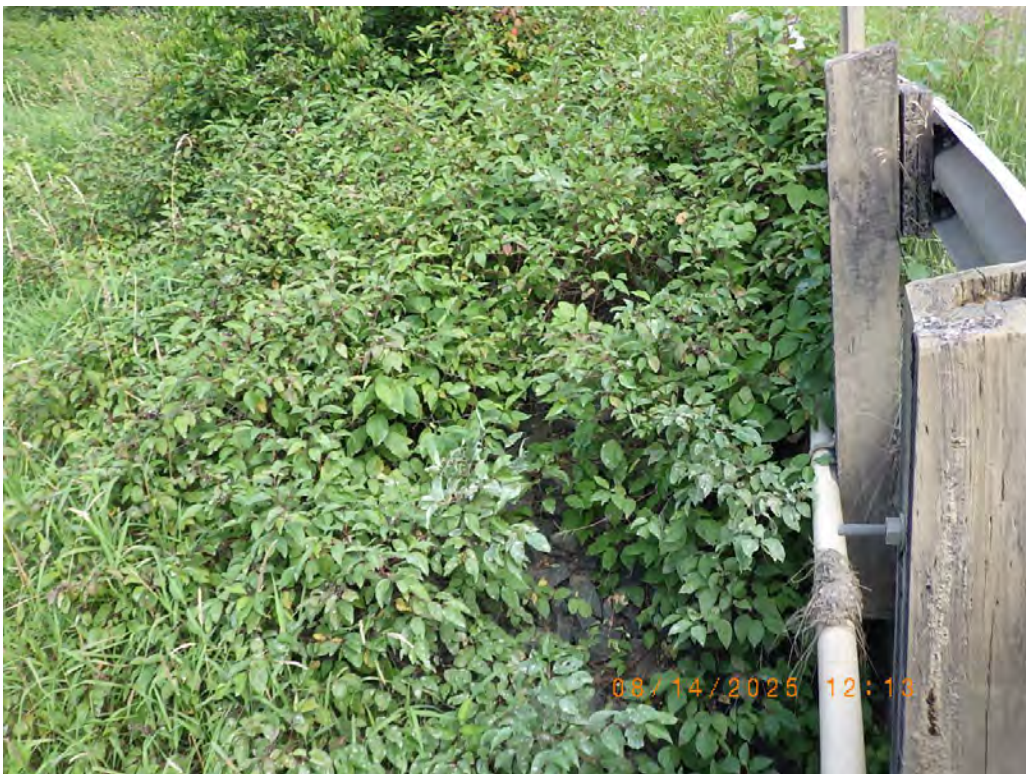
Photo 14: Northwest embankment.

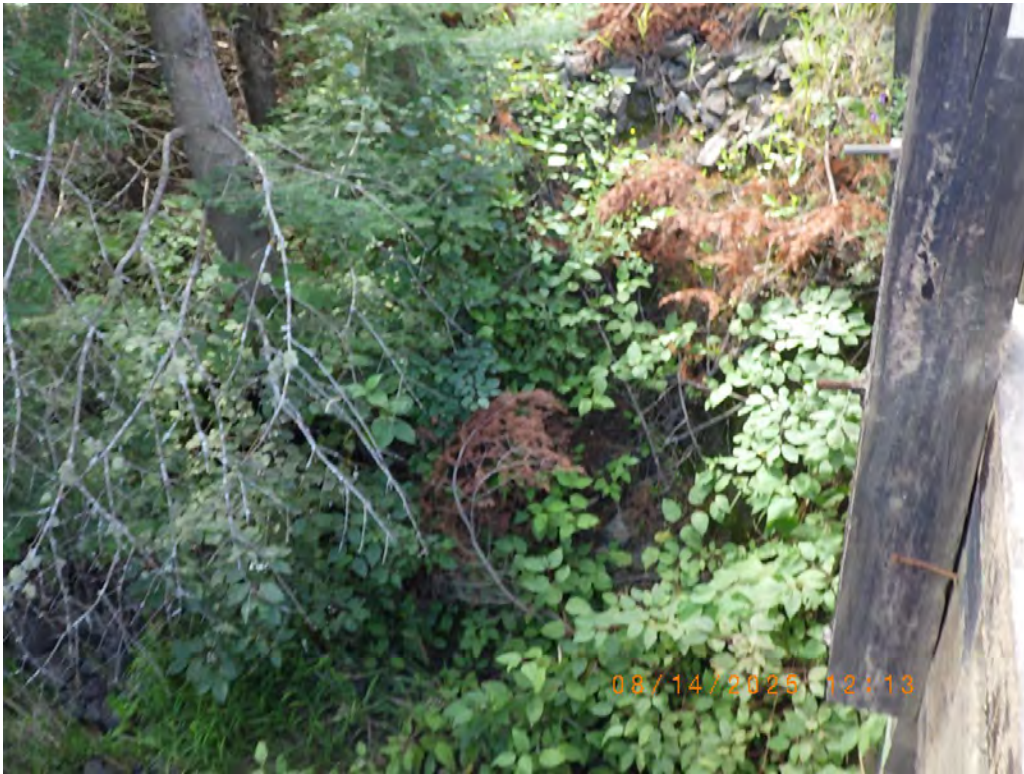
Photo 15: Southeast embankment.

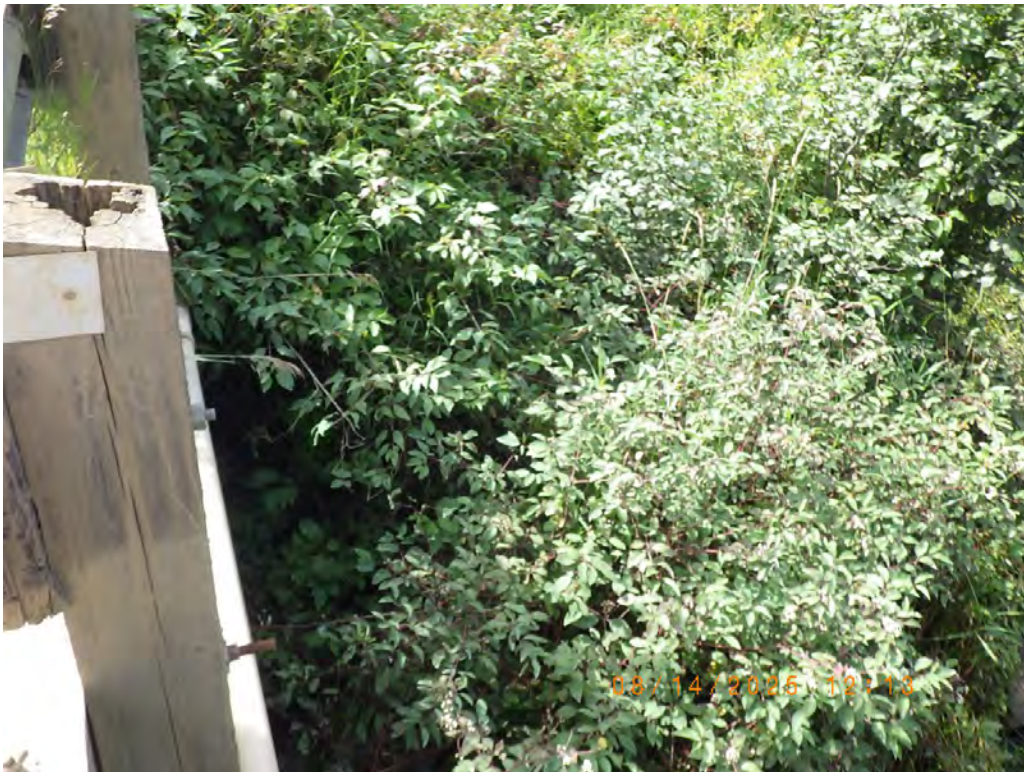
Photo 16: Southwest embankment.

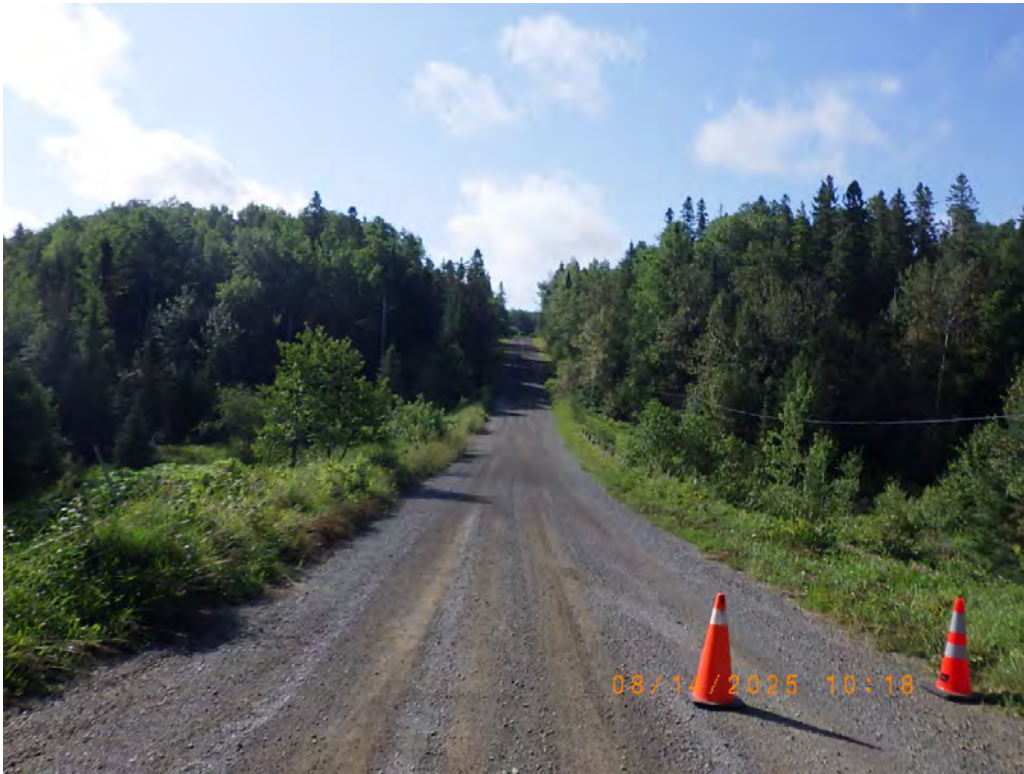
Photo 1: North approach.

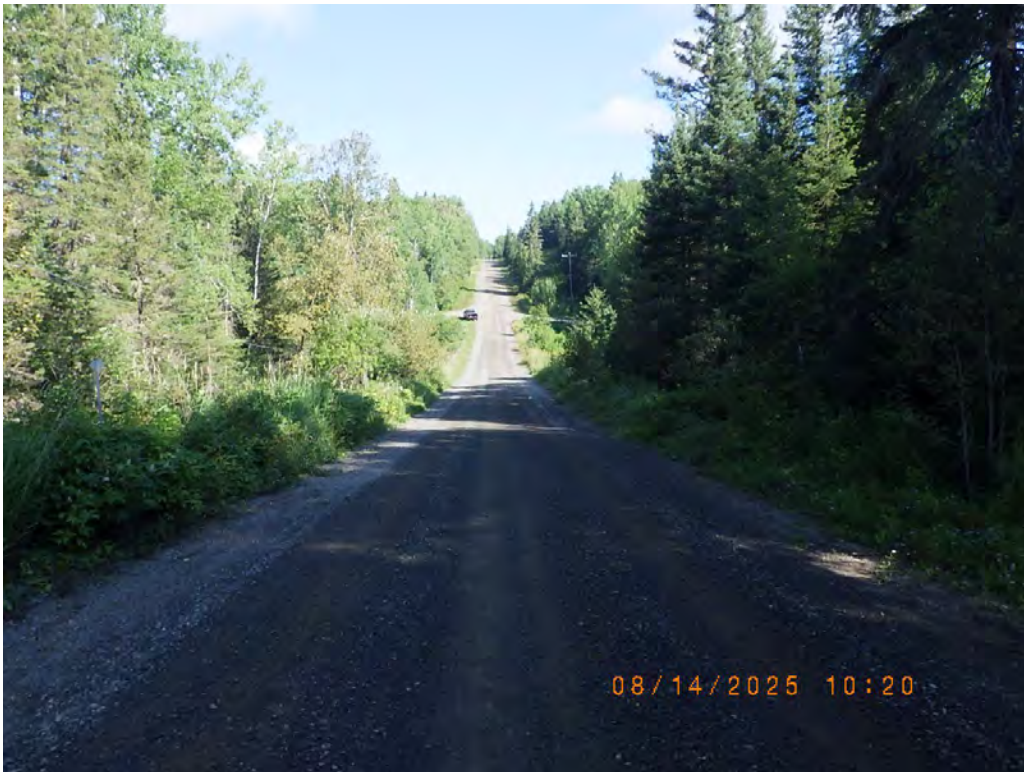
Photo 2: South approach.

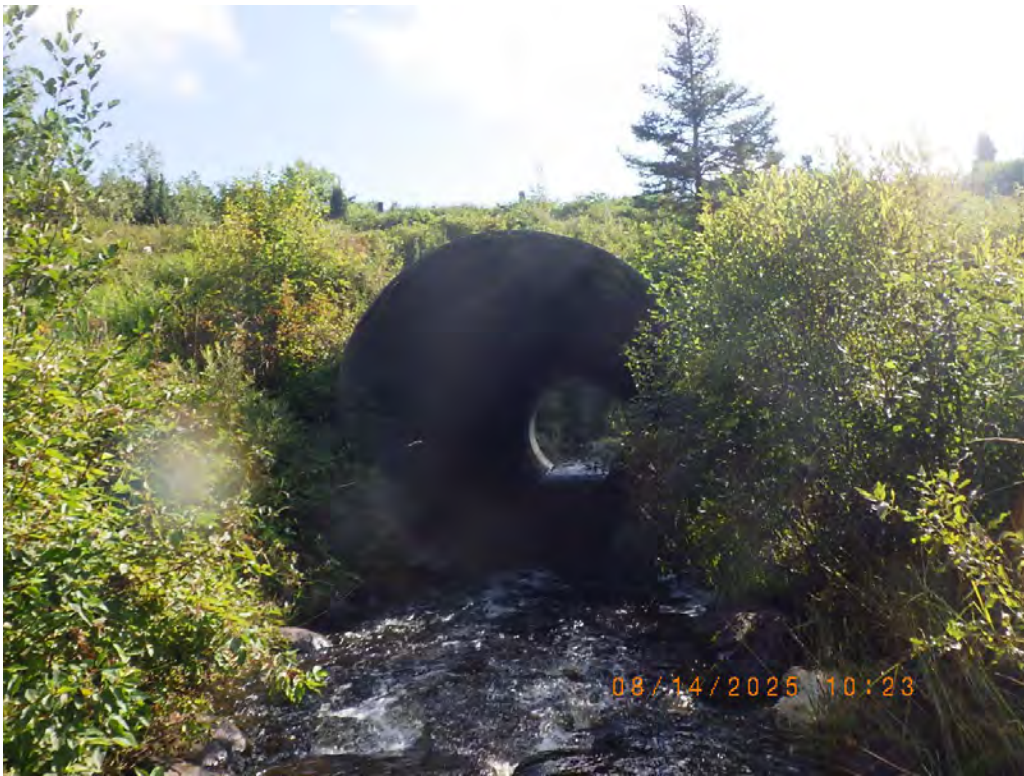
Photo 3: Upstream elevation.

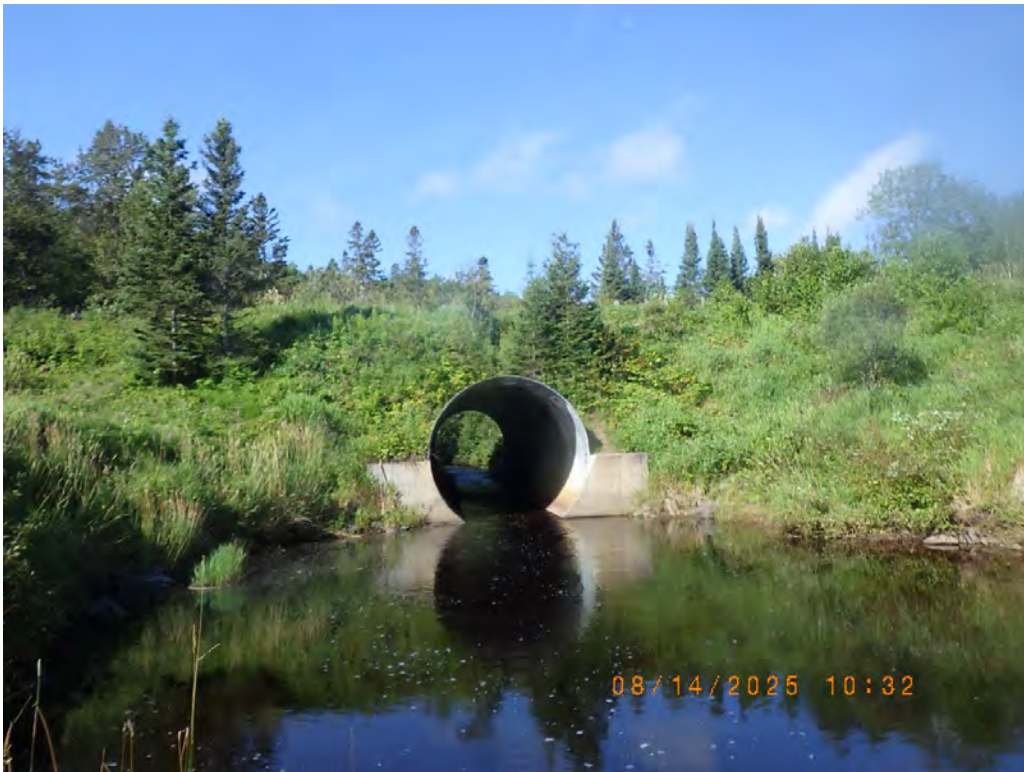
Photo 4: Downstream elevation.

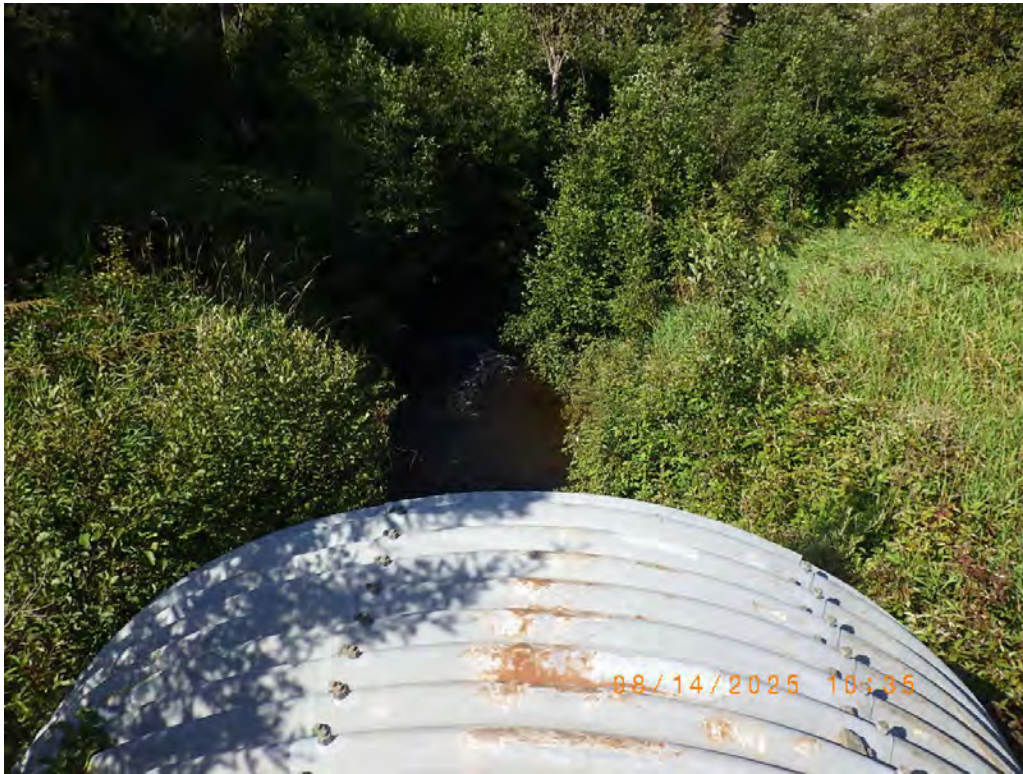
Photo 5: Upstream view.

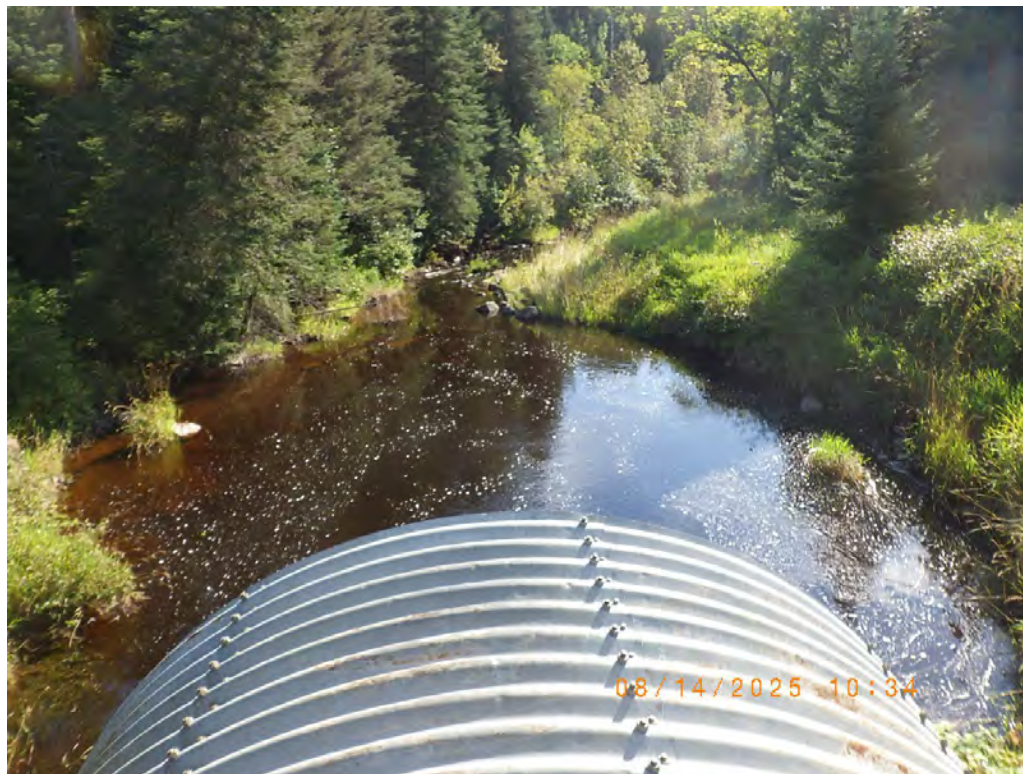
Photo 6: Downstream view.

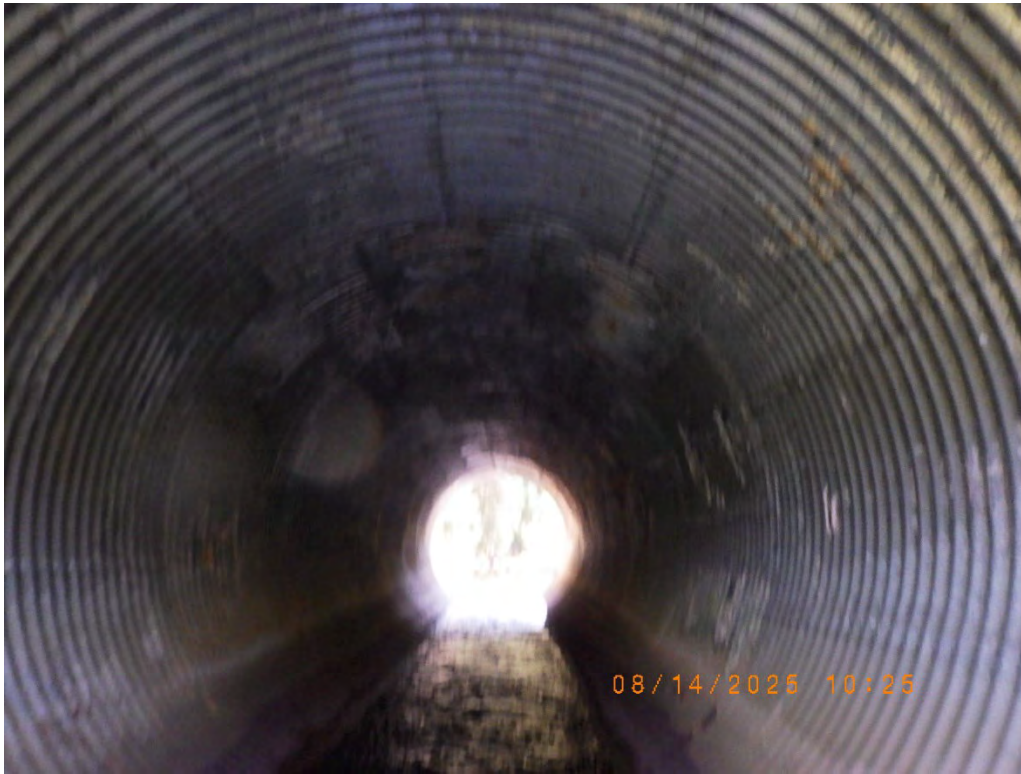
Photo 7: View inside barrel.

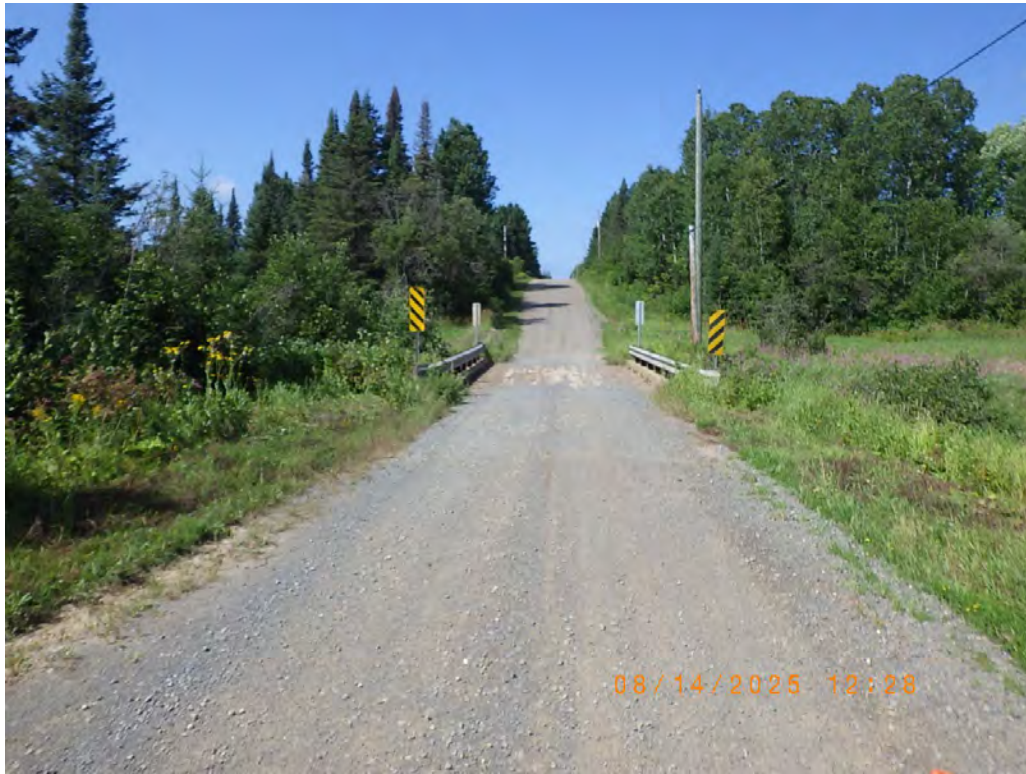
Photo 1: East approach.

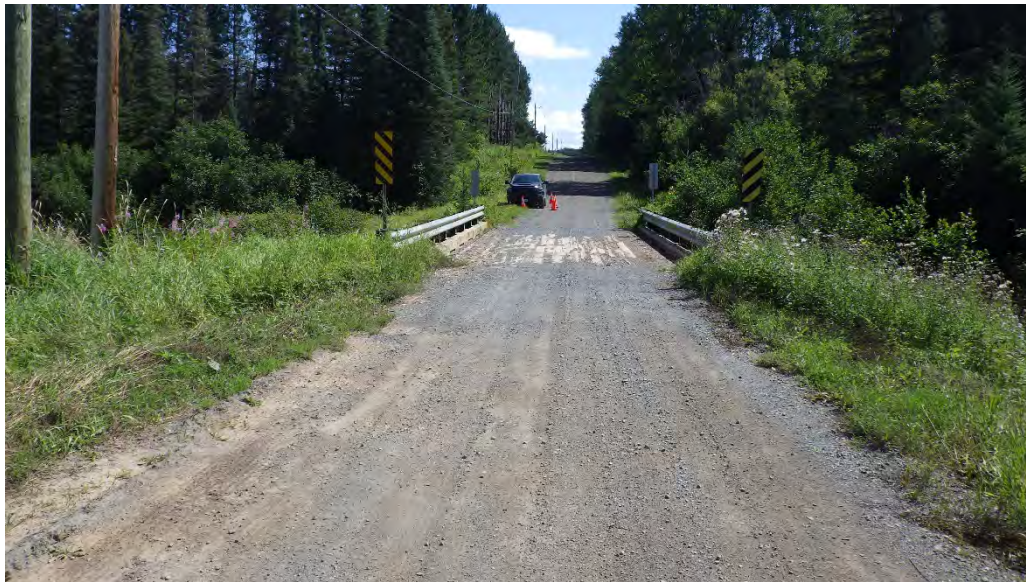
Photo 2: West approach.

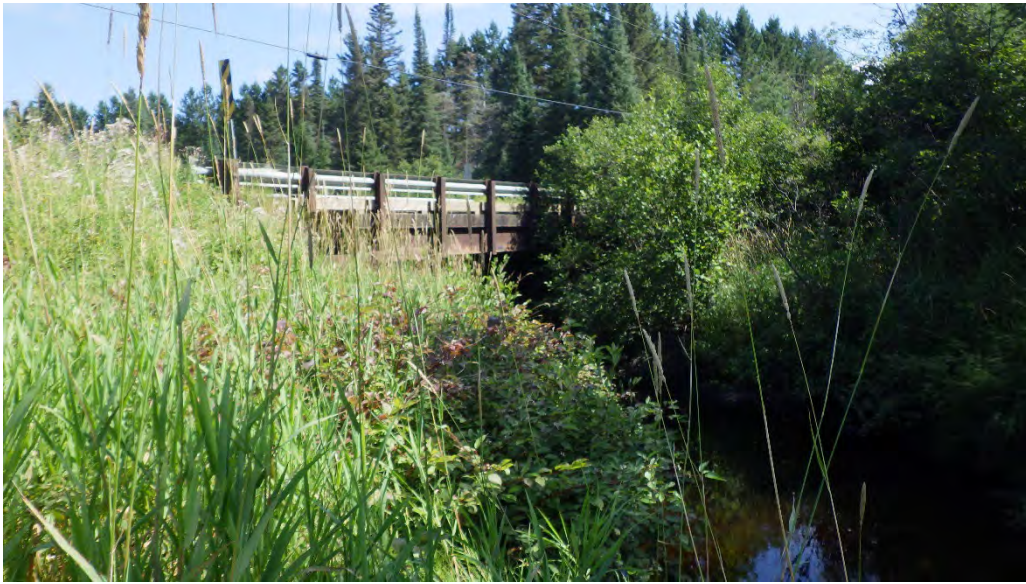
Photo 3: Upstream elevation looking north.

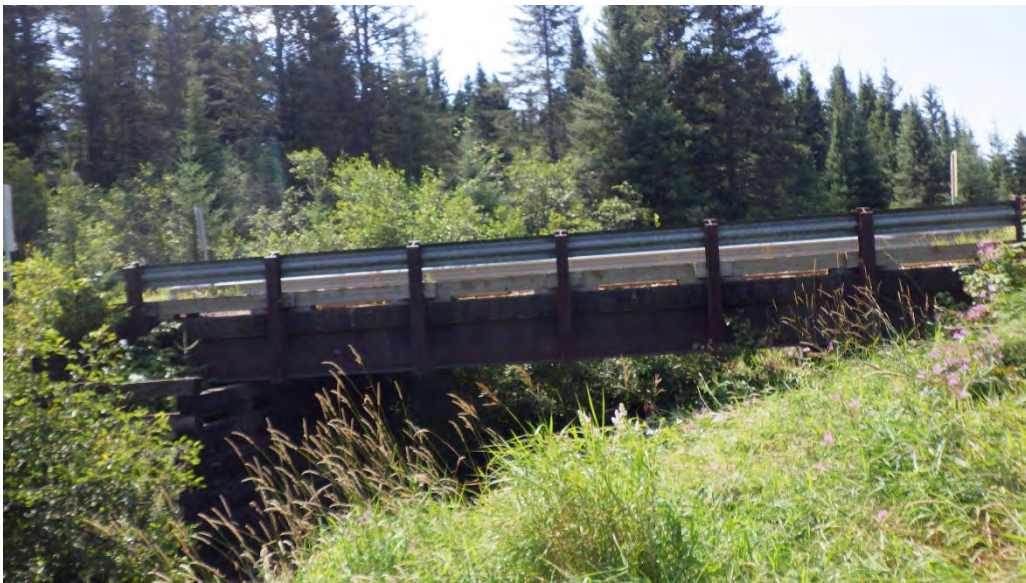
Photo 4: Downstream elevation looking south.

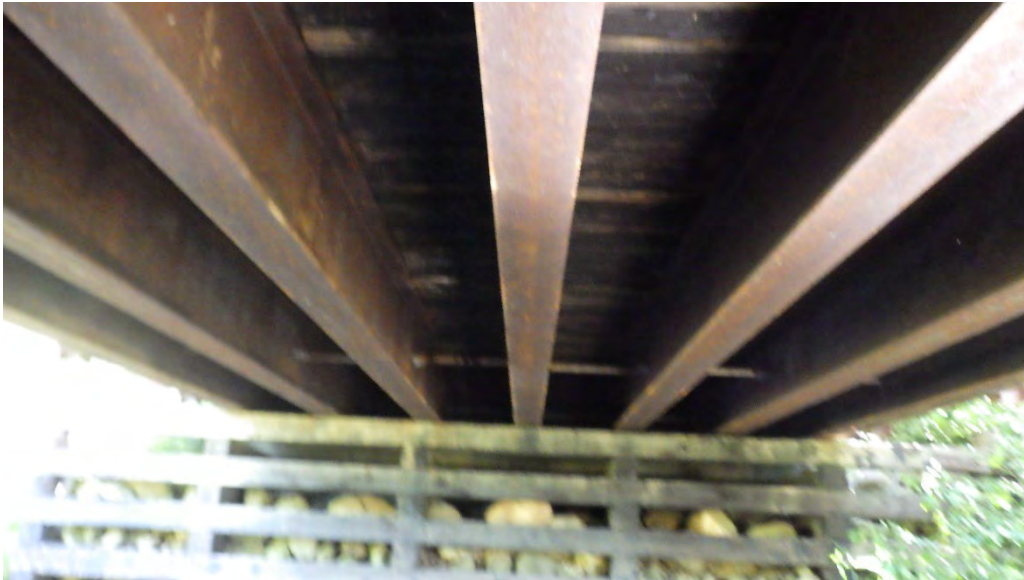
Photo 5: Deck cross-section.

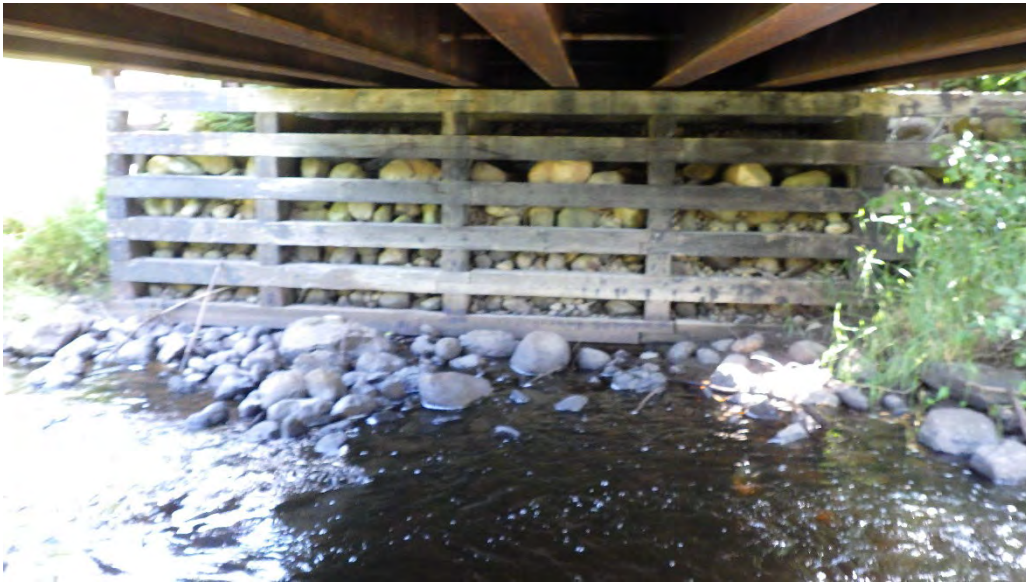
Photo 6: Underside of bridge.

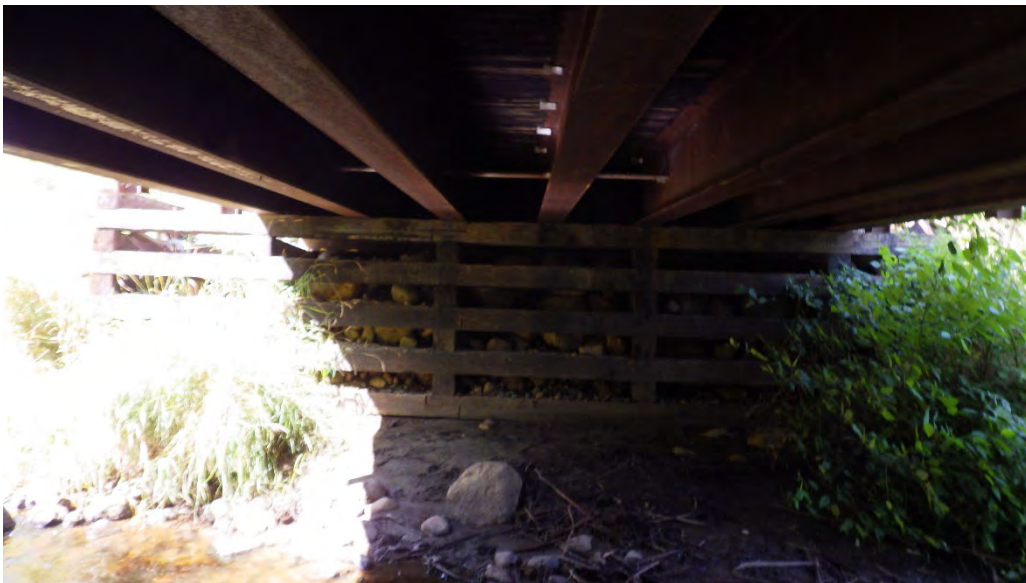
Photo 7: East abutment and embankment.

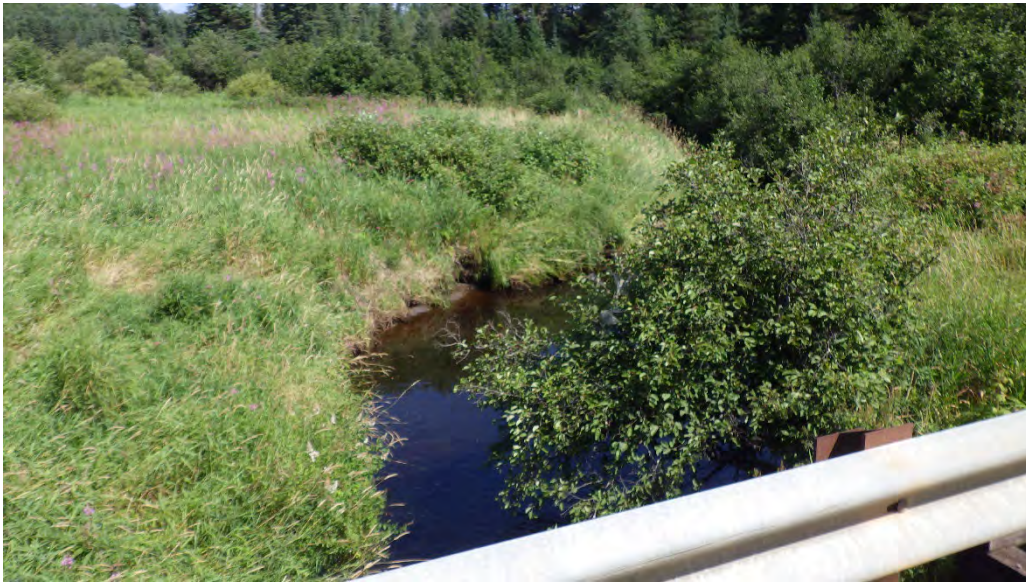
Photo 8: West abutment and embankment.

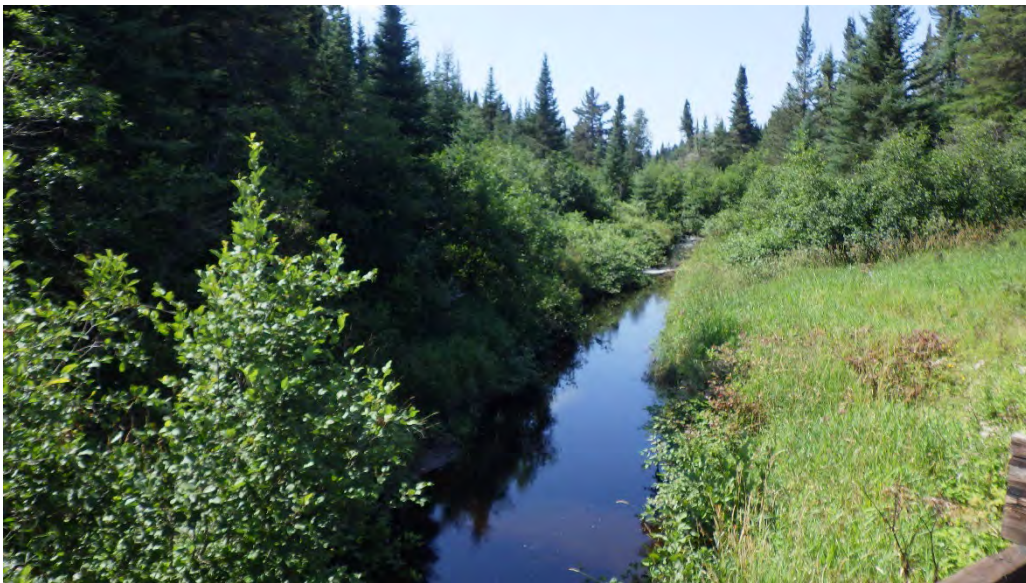
Photo 9: Downstream view from bridge.
