Structural Inspection Two Bridges and One Culvert

FOR
CONMEE TOWNSHIP

Structural Inspection Enders Road Bridge over Brule Creek

Structural Inspection Ilkka Drive Culvert at Brule Creek

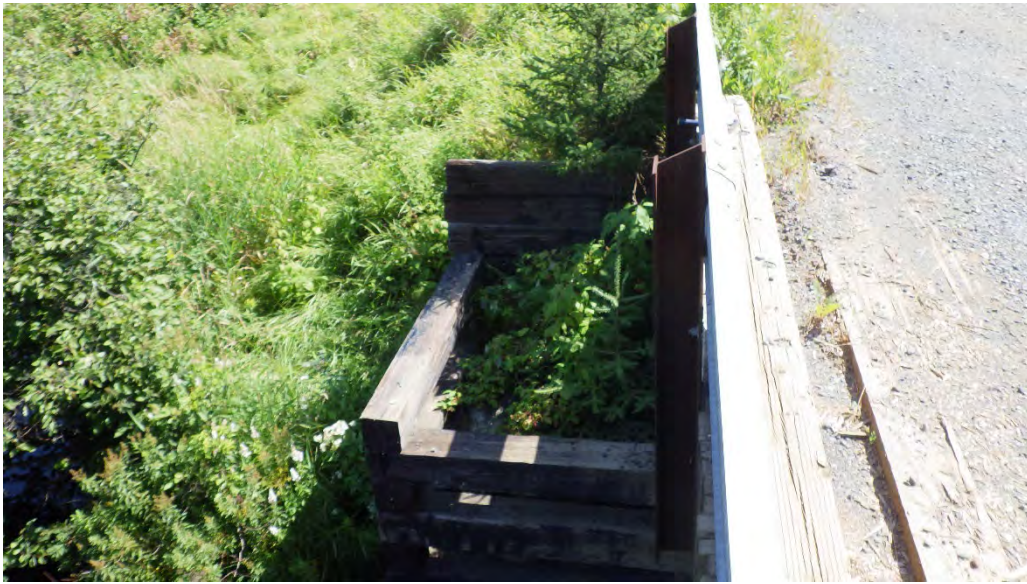
Photo 10: Upstream view from bridge.

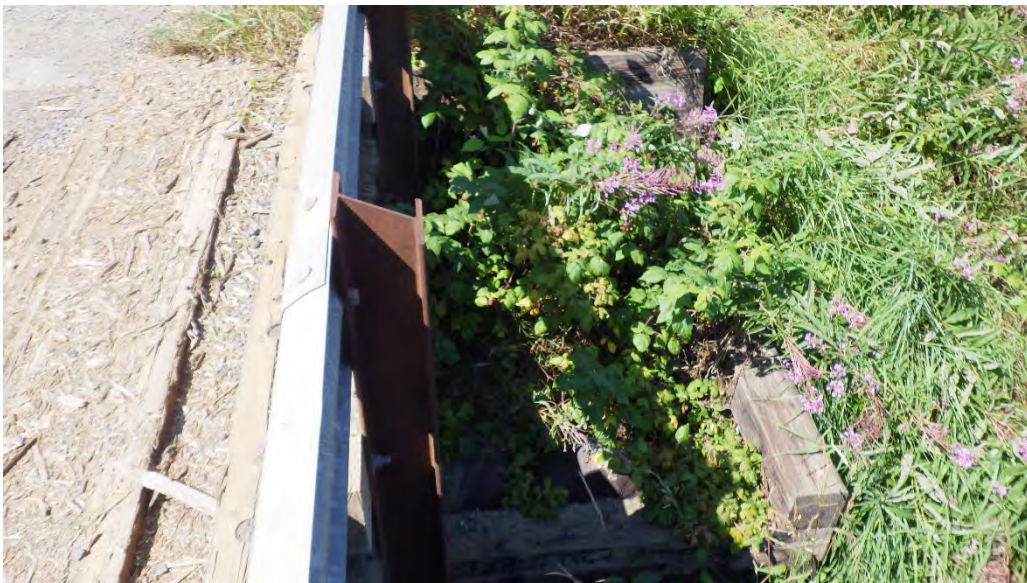
Photo 11: Northeast embankment.

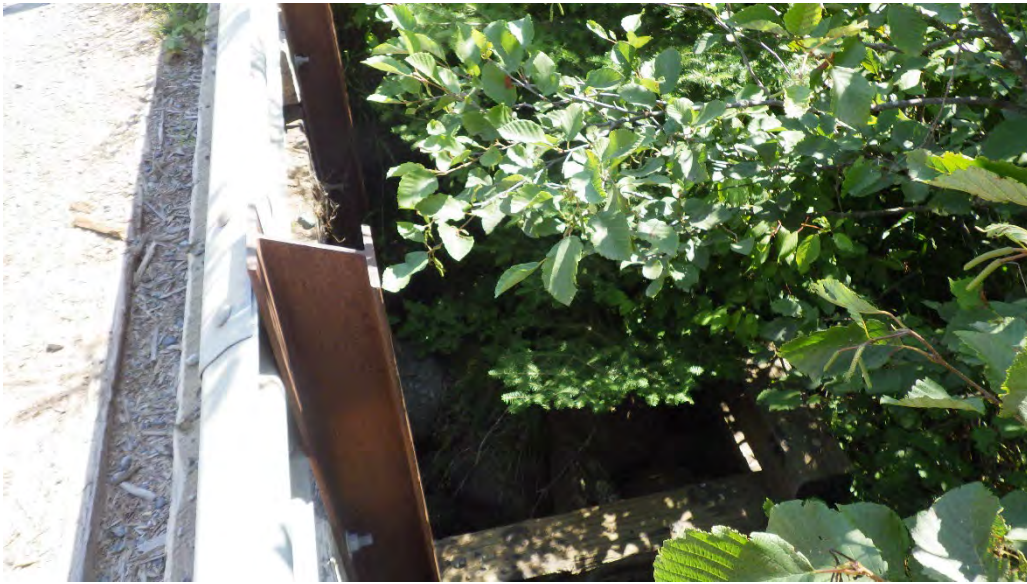
Photo 12: Northwest embankment.

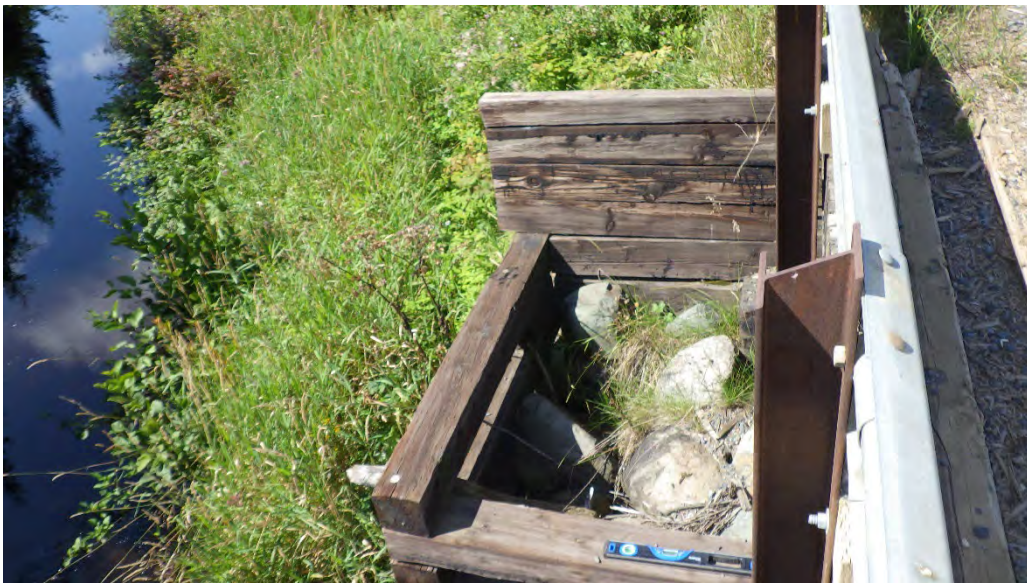
Photo 13: Southeast embankment.
